ASBESTOS CONTAINING MATERIALS SURVEY REPORT

BUILDING 403
Library
Bundaberg Campus

Report Number 622.10968.00010-R01- BLD 403-ASR

03 October 2017

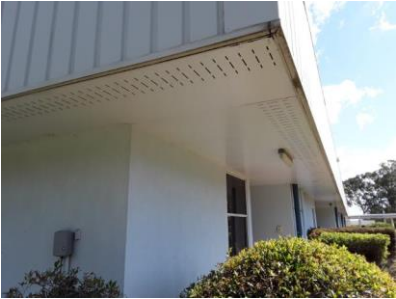
Ground Floor SOFFITS	SOFFIT SHEETING - ALL ELEVATIONS, Fibrous Cement	m ²	NAD
3-901

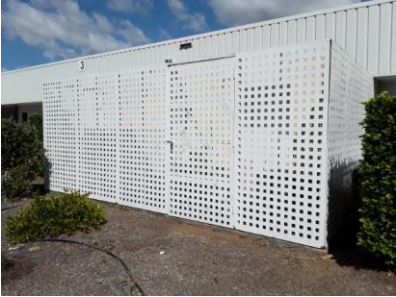
Ground Floor EXTERNAL WALL SHEETING	LATTICE WALL SHEETING - NORTH AND SOUTH ELEVATION, Fibrous Cement	65m ²	NAD
