COMPLIANCE ASBESTOS RE-INSPECTION AND RISK ASSESSMENT

NOVEMBER 2021

J033440

GLADSTONE CITY CAMPUS_Building 5 Derby Road
Derby Road
Gladstone QLD
4680

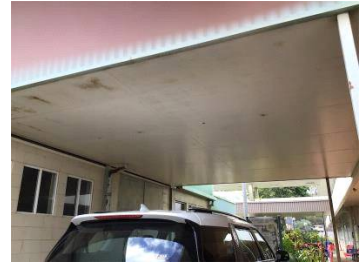
Location	Building 5 - Office Store - Ground Floor - External - Awning - Fibre cement sheet - West elevation				
Hazard Type	Asbestos	Material Assessment		Disturbance Assessment	
Friability	Non-friable	Product Type	1	Occupancy	0
Sample No.	3-883 (AO000129)	Extent of damage	0	Disturbance	1
Result	Positive Chrysotile	Surface Treatment	1	Exposure	0
		Asbestos Type	1	Maintenance	0
Item Number	1	Material Score	3	Disturbance Score	1
		Priority Score	4	Very Low
