## ASBESTOS CONTAINING MATERIALS SURVEY REPORT

BUILDING 404  
DFM Shed  
Bundaberg Campus

Report Number 622.10968.00010-R01-BLD404-ASR

03 October 2017

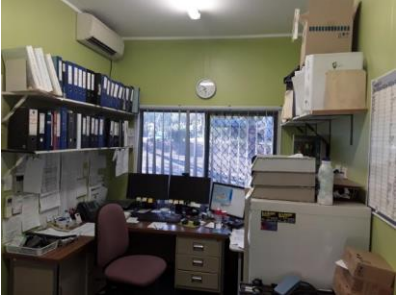
Ground Floor G.01 OFFICE	WALL SHEETING - ALL ELEVATIONS, Fibrous Cement	32m <sup>2</sup>	NAD
3-903

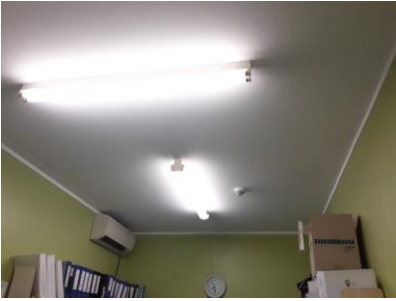
Ground Floor G.01 OFFICE	CEILING SHEETING, Fibrous Cement	10m <sup>2</sup>	NAD

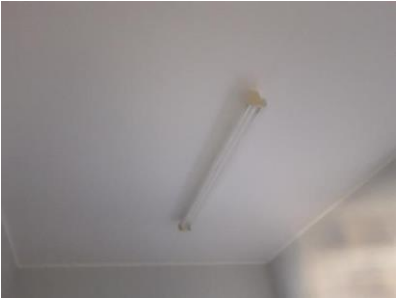
Ground Floor G.02 OFFICE	CEILING SHEETING, Fibrous Cement	10m <sup>2</sup>	NAD
Similar to 3-902

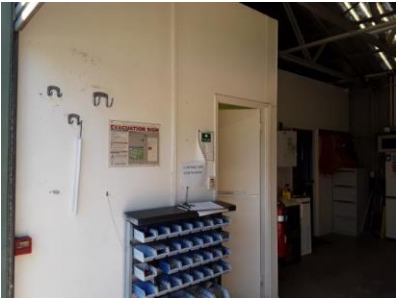
Ground Floor G.04 WORKSHOP	WALL SHEETING - EAST ELEVATION , Fibrous Cement	24m <sup>2</sup>	NAD
