## ASBESTOS CONTAINING MATERIALS SURVEY REPORT

BUILDING 609  
PELM CELL 2 & 4  
Gladstone Marina Campus  
Bryan Jordan Drive, Gladstone Marina, Queensland

Report Number 622.10968.00000/0020-R01-BLD 609

28 September 2017

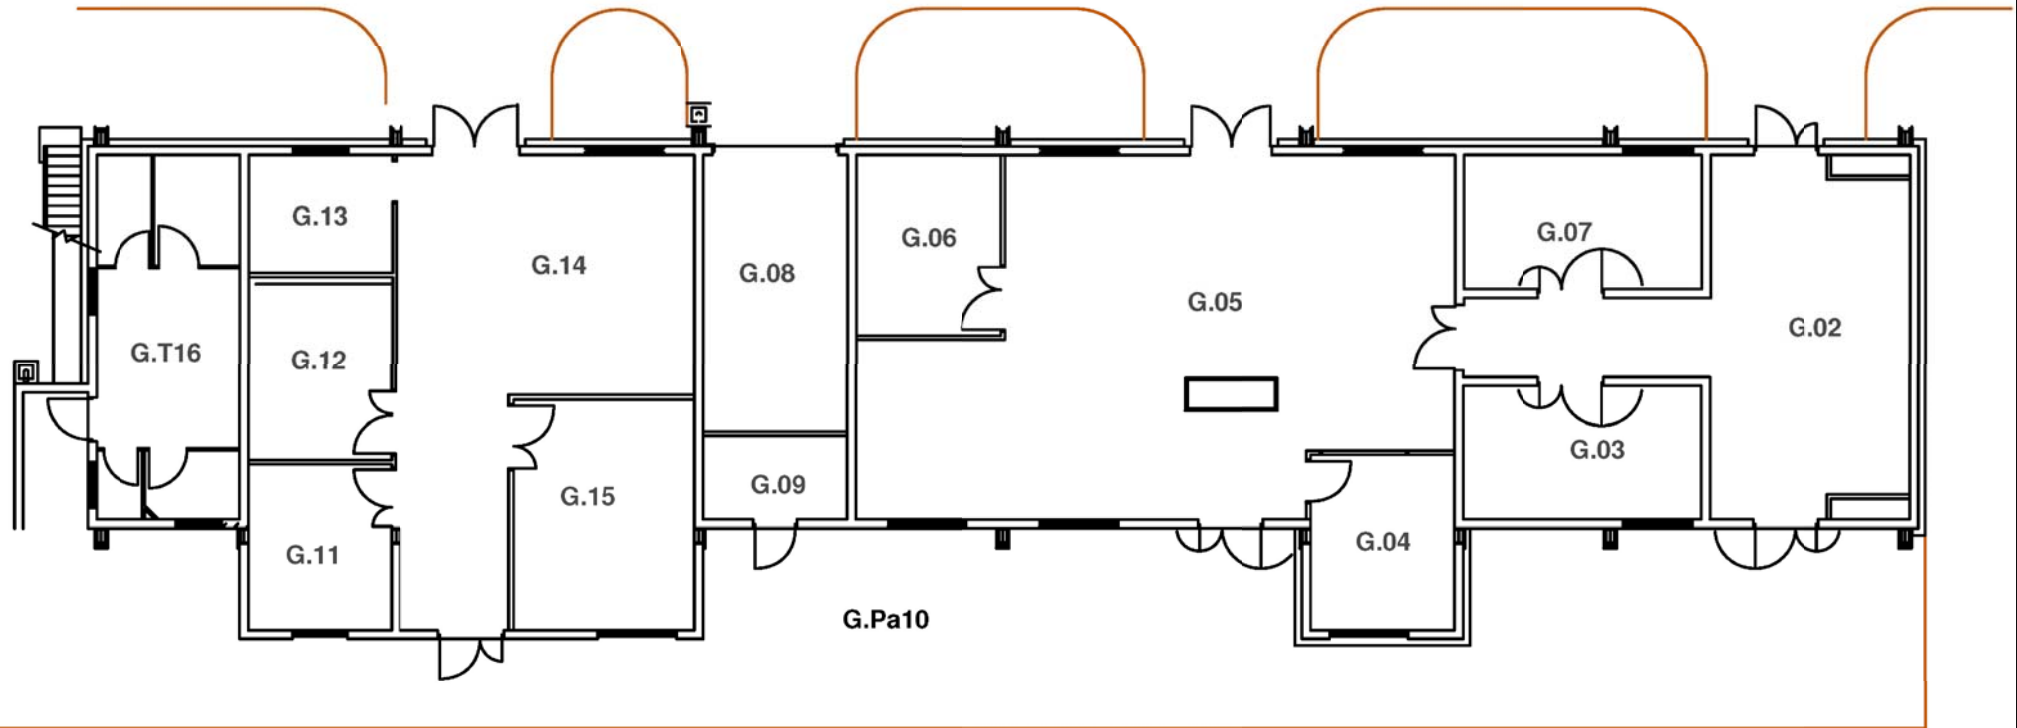
Building No:	609
Inspection Date:	24/07/17 - 27/07/17
Inspected By:	NC
Figure No.:	SLR62210968-609-01
Drawn By:	LF
Drawn Date:	07/9/17

LEGEND:  
 No Samples Taken  
 No Asbestos Detected
