# ASBESTOS CONTAINING MATERIALS SURVEY REPORT

Block D  
Emerald Campus

Report Number 622.10968.00000/0050-R01-V01-ASR-Block D

11 October 2017

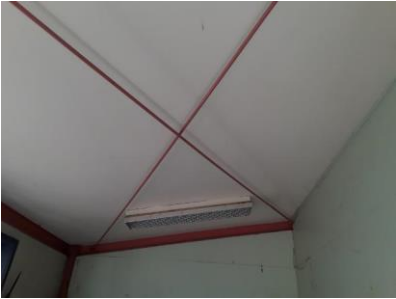
Sample No./ Visual Observation	Photo	Location			Analysis
		Int / Ext Floor Specific Location	Material Application	Extent	Result
1-070

Ground Floor G.04	Ceiling , Fibrous Cement	10m <sup>2</sup>	NAD
Similar to 1-056 (sampled in Block A)

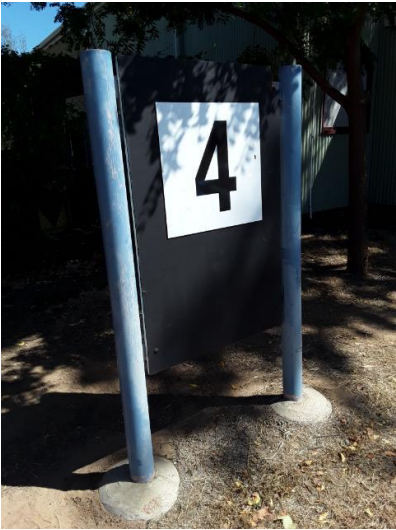
External East side building number sign	sign , Fibrous Cement	1m <sup>2</sup>	NAD

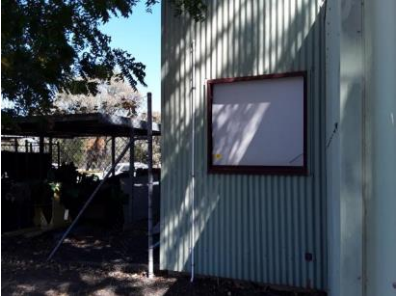
Sample No./ Visual Observation	Photo	Location			Analysis
		Int / Ext Floor Specific Location	Material Application	Extent	Result
1-071

External G.02 external east side	Infill to window, Fibrous Cement	1m <sup>2</sup>	NAD
