ASBESTOS CONTAINING MATERIALS SURVEY REPORT

BUILDING 405
Academic and Teaching
Bundaberg Campus

Report Number 622.10968.00010-R01-Bld 405-ASR

03 October 2017

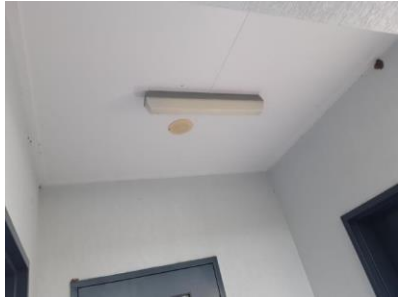
Ground Floor EXTERNAL ENTRANCE CEILING - NORTH AND EAST ELEVATIONS	CEILING SHEETING, Fibrous Cement	13m ²	NAD
3-905

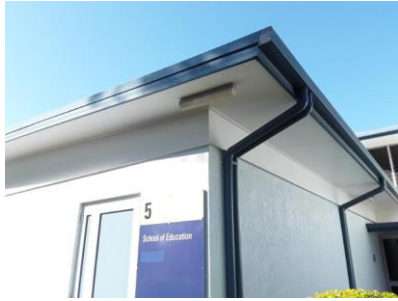
Ground Floor SOFFIT	SOFFIT SHEETING - ALL ELEVATIONS, Fibrous Cement	100m ²	NAD

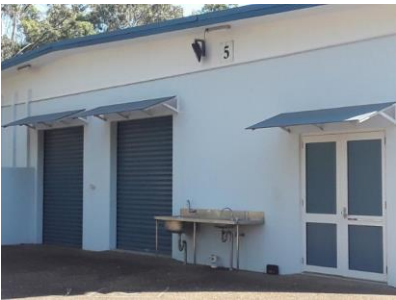
Ground Floor EXTERNAL SUN HOODS	SUN HOOD SHEETING - ALL ELEVATIONS, Fibrous Cement	14no	NAD
