ASBESTOS CONTAINING MATERIALS SURVEY REPORT

BUILDING 610
GLADSTONE ENGINEERING CENTRE PELM CELL 6 & 8
Gladstone Marina Campus
Bryan Jordan Drive, Gladstone Marina, Queensland

Report Number 622.10968.00000/0020-R01-Bld 610-ASR

28 September 2017

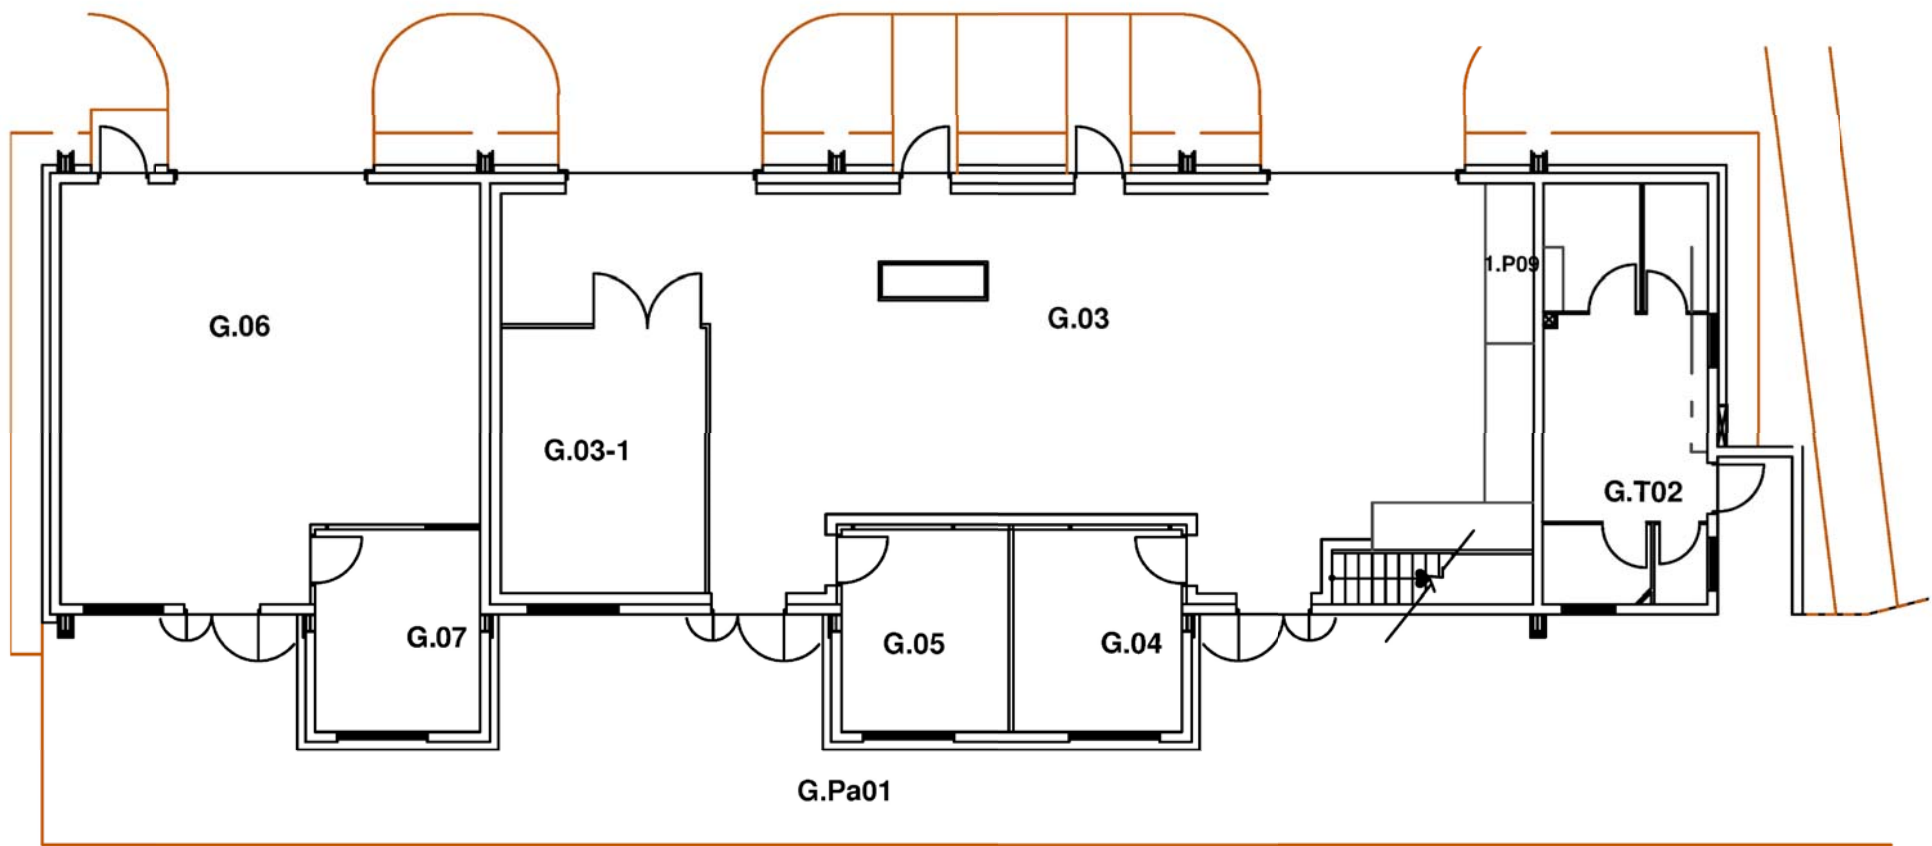
Building No:	610
Inspection Date:	24/07/17 - 27/07/17
Inspected By:	NC
Figure No.:	SLR62210968-610-01
Drawn By:	LF
Drawn Date:	07/9/17

No Samples Taken
No Asbestos Detected
