## ASBESTOS CONTAINING MATERIALS SURVEY REPORT

Building 5 - Fire Pump Shed  
Emerald Campus

Report Number 622.10968.00000/0050-R01-V01-ASR-BLD 5 Fire Pump Shed

11 October 2017

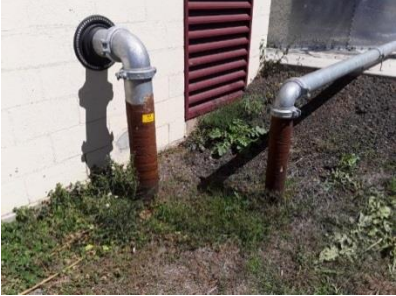
External North side	Textile material around lower section of pipes, Woven Product	3lin m	NAD
