## ASBESTOS CONTAINING MATERIALS SURVEY REPORT

**BUILDING 406**  
Refectory  
Bundaberg Campus

Report Number 622.10968.00010-R01-Bld406-ASR

03 October 2017

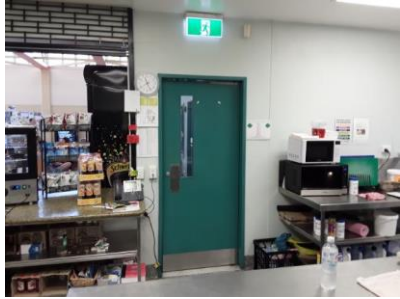
Ground Floor G.09	WALL SHEETING - SOUTH ELEVATION - AROUND DOOR, Fibrous Cement	2m <sup>2</sup>	NAD
Similar to 3-908

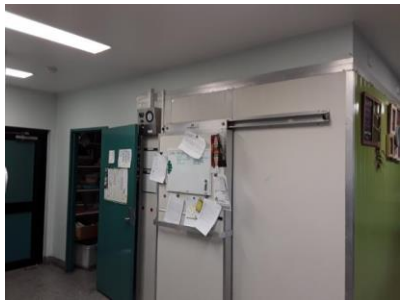
Ground Floor G.09	WALL SHEETING - NORTH ELEVATION - AROUND COLDROOM, Fibrous Cement	8m <sup>2</sup>	NAD
Similar to 3-908

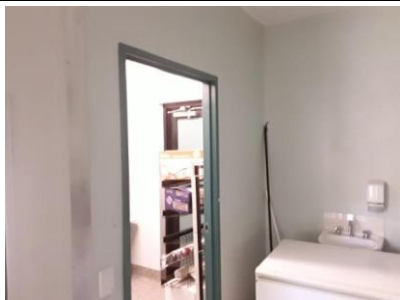
Ground Floor G.12	WALL SHEETING - SOUTH ELEVATION - AROUND ROLLER DOOR AND STORE ROOM DOOR, Fibrous Cement	8m <sup>2</sup>	NAD
