ASBESTOS CONTAINING MATERIALS SURVEY REPORT

BUILDING 407
Demountable (Nulloo Yumbah/Academic)
Bundaberg Campus

Report Number 622.10968.00010-R01-BLD 407-ASR

03 October 2017

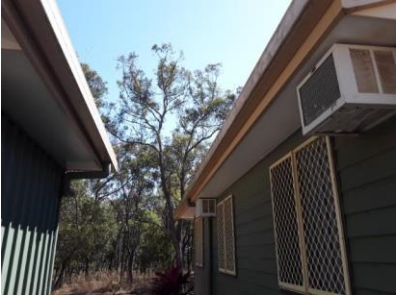
Ground Floor SOFFIT	SOFFIT SHEETING - NORTH, EAST AND WEST ELEVATIONS, Fibrous Cement	20m ²	NAD
3-911

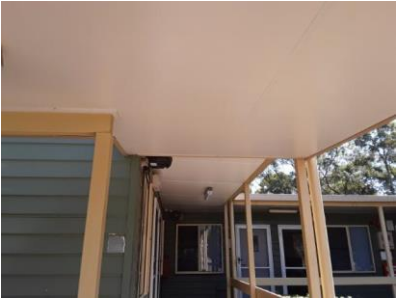
Ground Floor WALKWAY CEILING	CEILING SHEETING TO WALKWAY, Fibrous Cement	40m ²	NAD

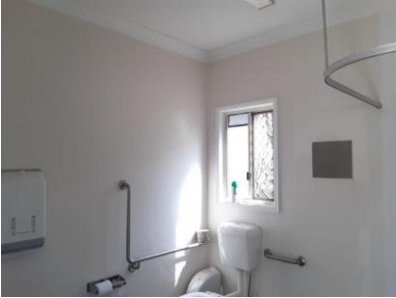
Sample No./ Visual Observation	Photo	Location			Analysis
		Int / Ext Floor Specific Location	Material Application	Extent	Result
3-912

Ground Floor G.12 TOILET	WALL SHEETING - ALL ELEVATIONS, Fibrous Cement	22m ²	NAD
