ASBESTOS CONTAINING MATERIALS SURVEY REPORT

Cap College Workshop (Residential Precinct)
Building 044
Rockhampton North

Report Number 622.10968.00000/0040-R01-ASR-Blg044

27 December 2017

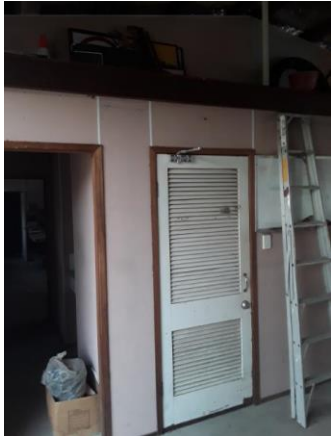
Ground Floor all dividing walls	Internal wall, Fibrous Cement	1m ²	NAD

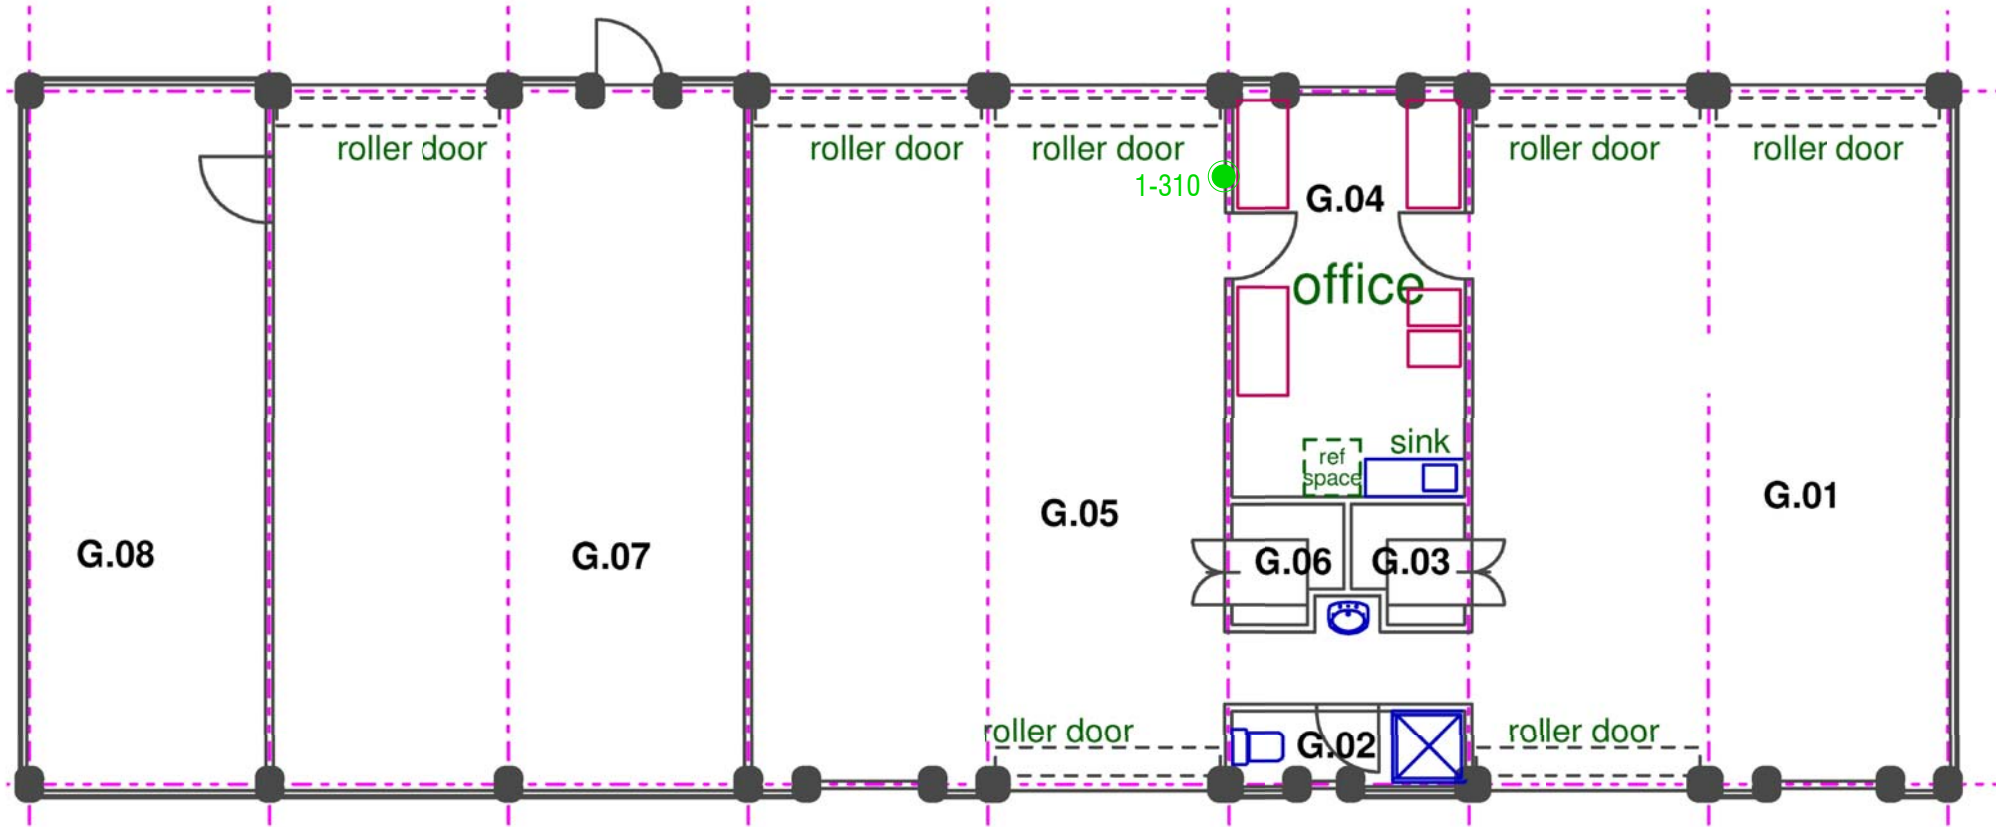
Building No:	44
Inspection Date:	Sept / Oct 2017
Inspected By:	NC / JH / SA
Figure No.:	SLR62210968-RN-44G-01
Drawn By:	LF
Drawn Date:	18/1/18

Sample location. No Asbestos Detected.
