ASBESTOS CONTAINING MATERIALS SURVEY REPORT

Building 7 Engine clean area
Emerald Campus

Report Number 622.10968.00000/0050-R01-V01-ASR-Bld7-Engine Clean Area

11 October 2017

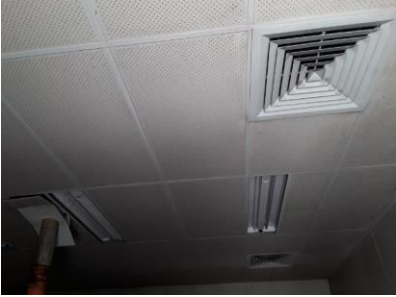
| Sample No./ Visual Observation | Photo | Location | | | Analysis |
|---|--|---|--|---|---|
| Similar to 1-083 | | Ground Floor C1.10 | Suspended ceiling tiles perforated , Fibrous Cement | 20m ² | NAD |

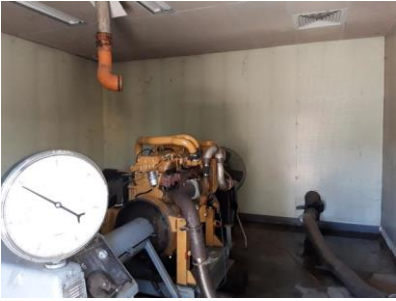
| Sample No./ Visual Observation | Photo | Location | | | Analysis |
|---|--|---|--|---|---|
| 1-093 | | Ground Floor C1.10 | Walls throughout perforated , Fibrous Cement | 60m ² | NAD |

| Sample No. | Description | Analysis Result |
|---|---|---|
| 1.093 | FIBRE CEMENT | Organic Fibres |

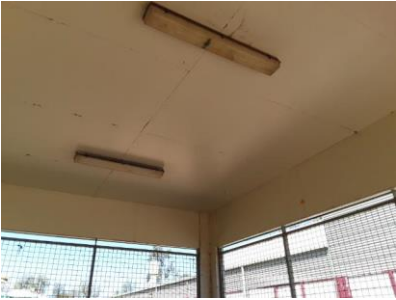
| Sample No./ Visual Observation | Photo | Location | | | Analysis |
|---|--|--|---|---|---|
| 1-094 | | Ground Floor Engine clean area | Upper east and south wall sheeting and ceiling , Fibrous Cement | 30 | NAD |

| Sample No. | Description | Analysis Result |
|---|---|---|
| 1.094 | FIBRE CEMENT | Organic Fibres |

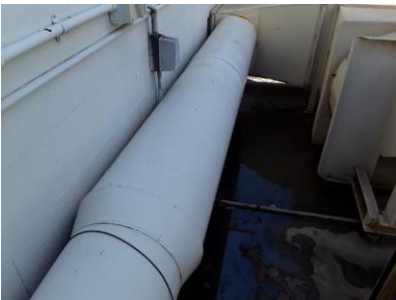
| Sample No./ Visual Observation | Photo | Location | | | Analysis |
|---|--|--|---|---|---|
| 1-095 | | External South side duct work round pipe work running north south | Insulation to inside of pipe, Insulation | unknown | NAD |

| Sample No. | Description | Analysis Result |
|---|---|---|
| 1.095 | FIBRE CEMENT | Organic Fibres and SMF |
