ASBESTOS CONTAINING MATERIALS SURVEY REPORT

Health Science B
Building 77
Rockhampton North

Report Number 622.10968.00000/0040-R01-ASR-Bld 77

27 December 2017

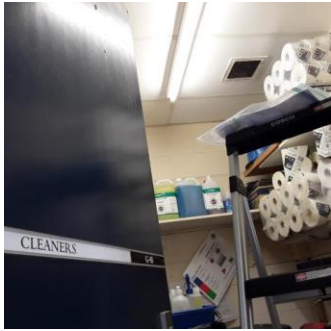
Ground Floor G.05 CLEANERS	Suspended ceiling tiles, Fibrous Cement	3.5m ²	NAD
Similar to 1-519

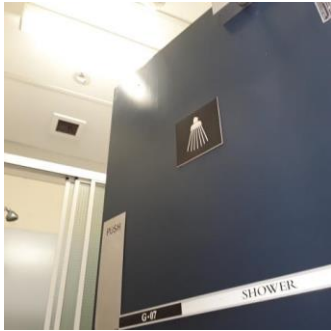
Ground Floor G.T06 FEMALE TOILET, G.07 SHOWER, G.T08 MALE TOILET	Suspended ceiling tiles, Fibrous Cement	9m ² m ²	NAD

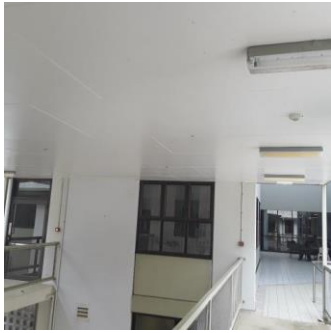
1st Floor EXTERNAL	Ceiling lining that links bldg 77 to bldg 18, Fibrous Cement	60m ²	NAD
1-521

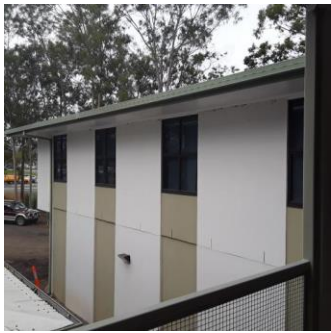
1st Floor EXTERNAL	Soffits all elevations to level 1, Fibrous Cement	74m ²	NAD
