ASBESTOS CONTAINING MATERIALS SURVEY REPORT

Flammable Liquids Store
Building 020
Rockhampton North

Report Number 622.10968.00000/0040-R01-ASR-Bld020

7 December 2017

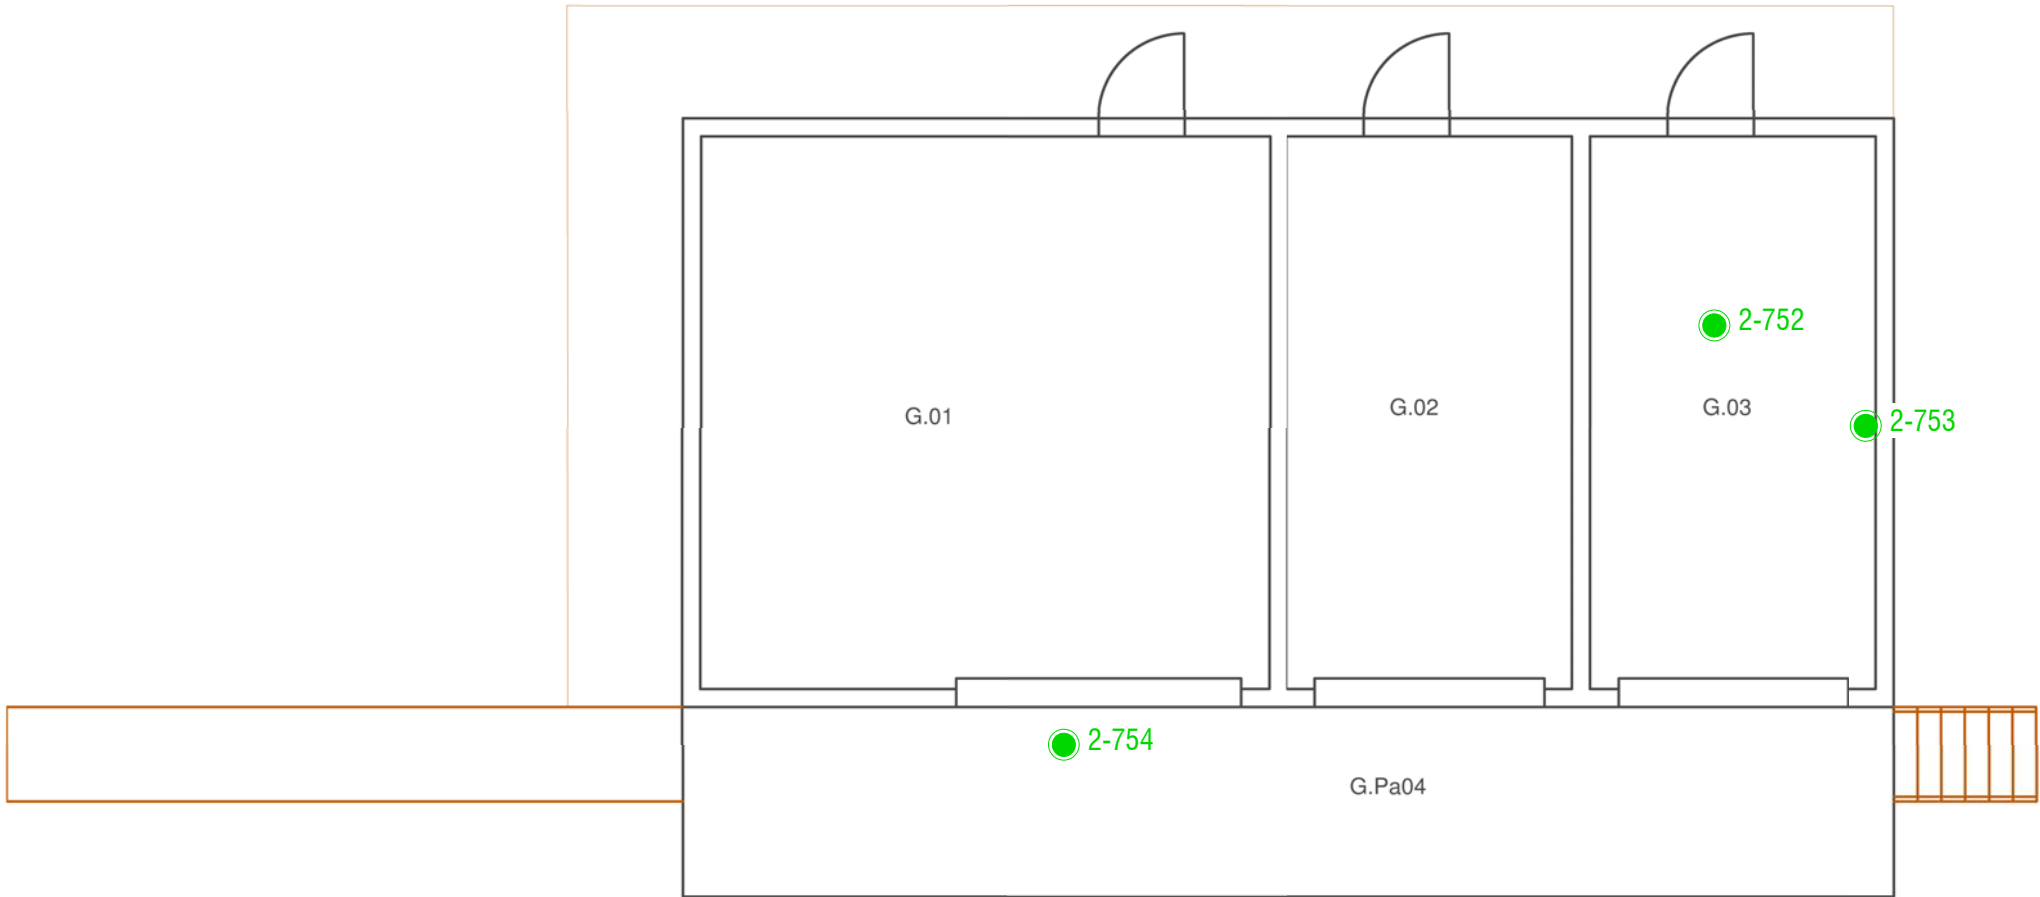
Building No:	020
Inspection Date:	Sept / Oct 2017
Inspected By:	NC
Figure No.:	SLR62210968-RN-020-01
Drawn By:	LF
Drawn Date:	9/11/17

Sample location
No Asbestos Detected
