COMPLIANCE ASBESTOS RE-INSPECTION AND RISK ASSESSMENT

J033461

ROCKHAMPTON NORTH CAMPUS_CQIRP Building 365 - Furnace
Bruce Highway
ROCKHAMPTON NORTH QLD
4700

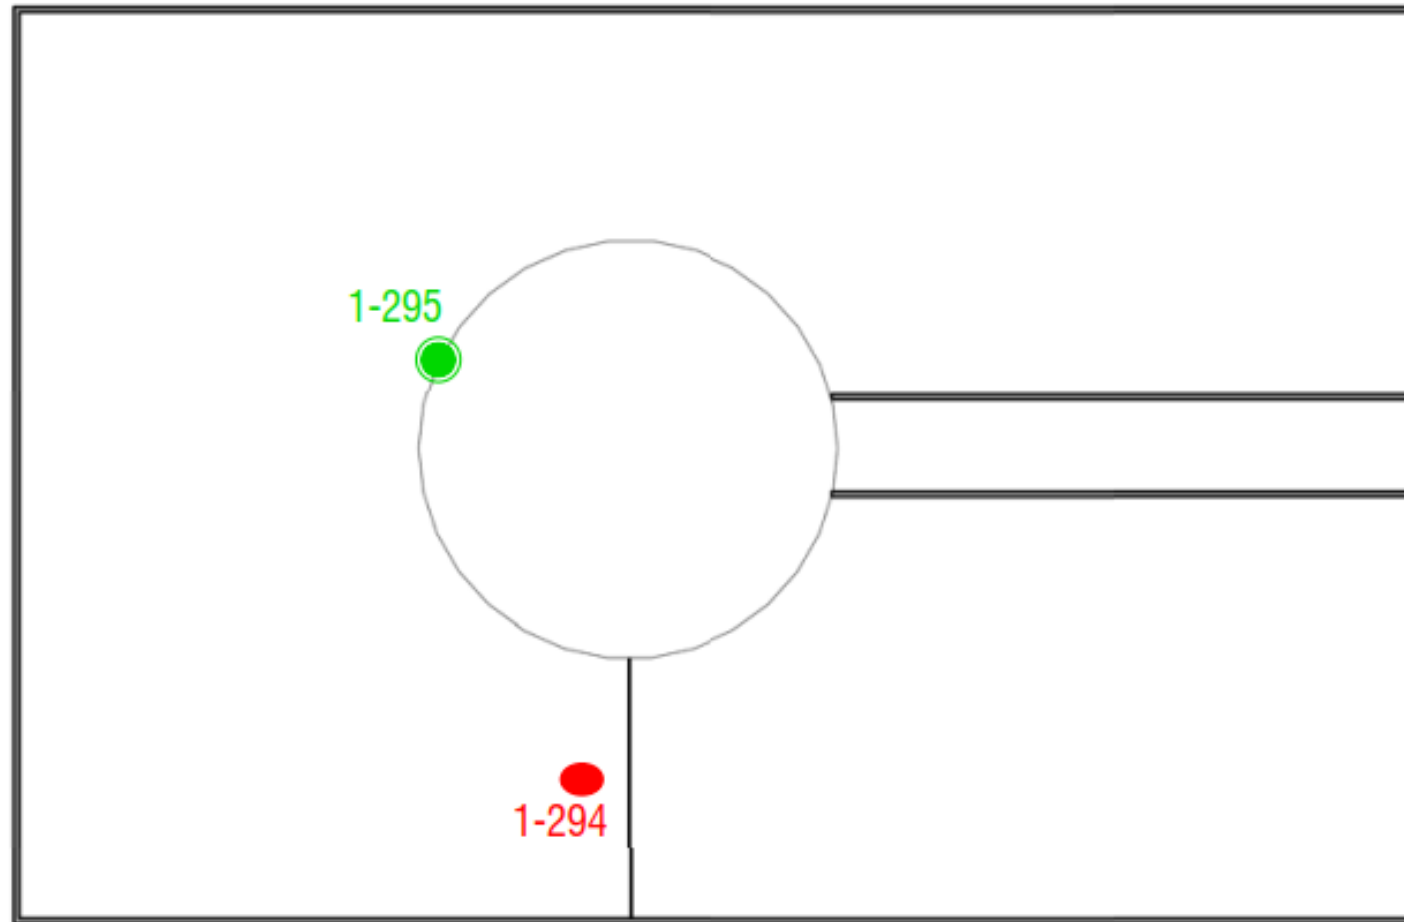
AREA: Furnace 365 - Ground Level

No positive items were identified within the scope of this inspection.

Sample location.
No Asbestos Detected
