ASBESTOS CONTAINING MATERIALS SURVEY REPORT

Baseball Facility
Building 080
Rockhampton North

Report Number 622.10968.00000/0040-R01-ASR-Bld080

27 December 2017

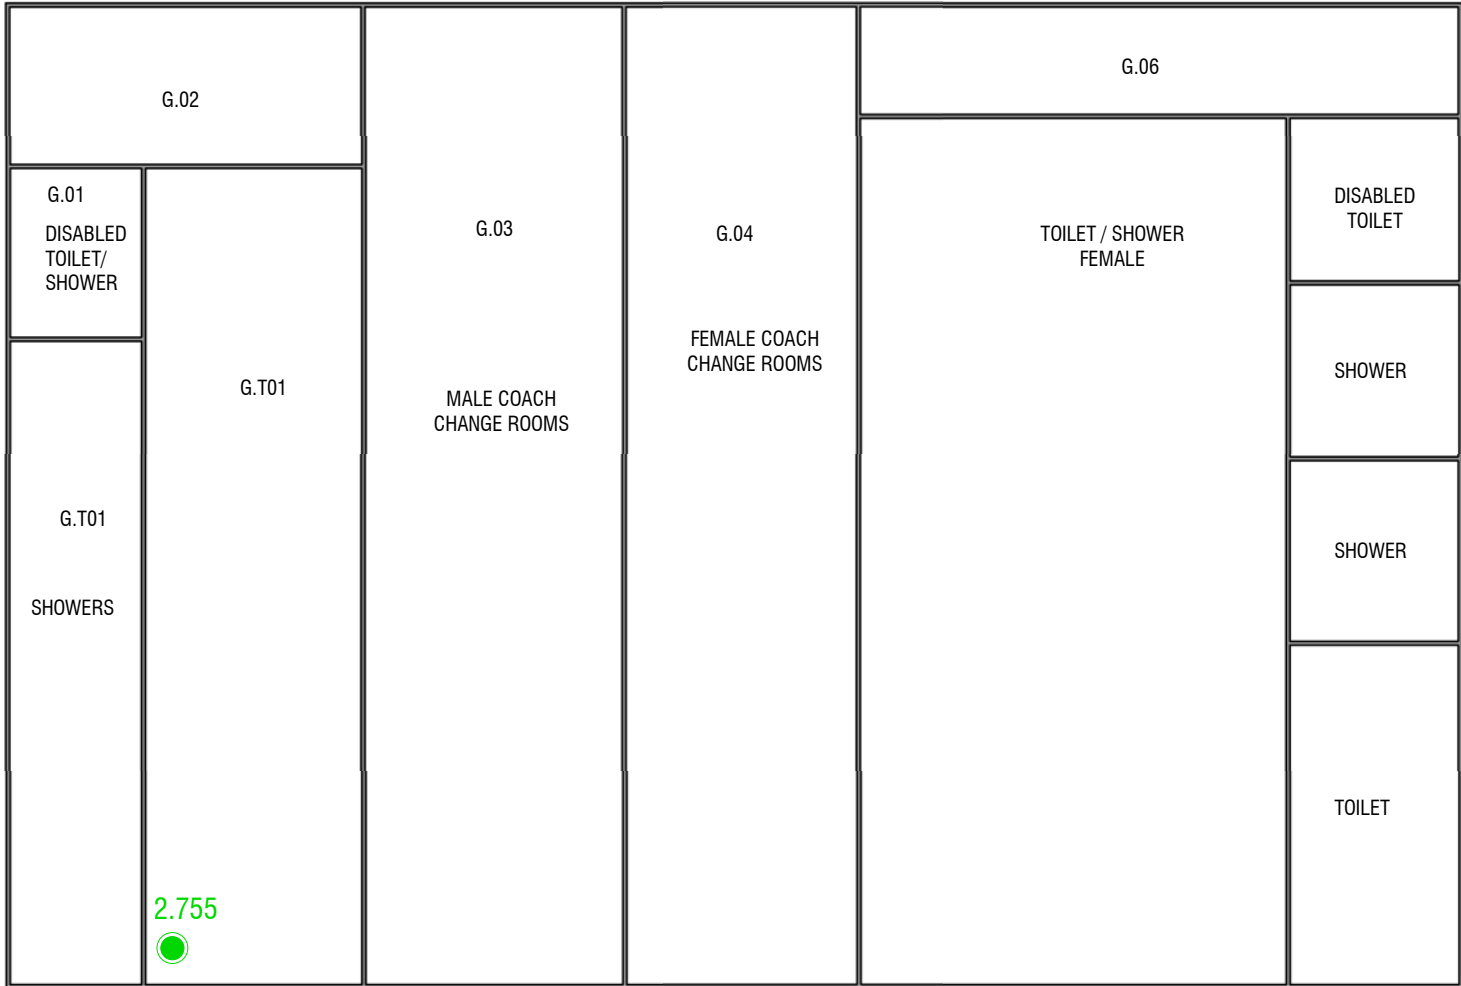
Building No:	80
Inspection Date:	Sept / Oct 2017
Inspected By:	NC / JH / SA
Figure No.:	SLR62210968-RN-80G-01
Drawn By:	LF
Drawn Date:	18/1/18

LEGEND:
 Sample location.
 No Asbestos Detected.
