ASBESTOS CONTAINING MATERIALS SURVEY REPORT

CQU International
Building 011
Rockhampton North

Report Number 622.10968.00000/0040-R01-ASR-Bld 011

7 December 2017

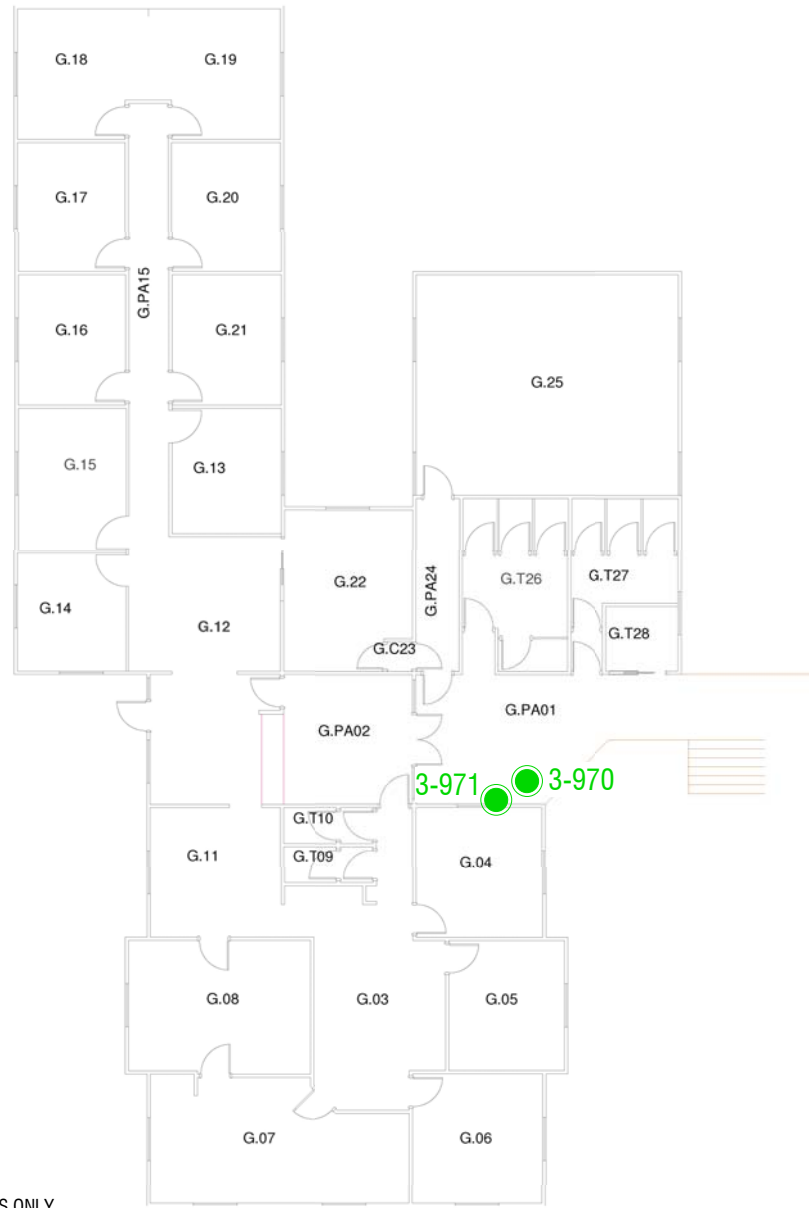
CQU International - Ground Level
Bruce Highway, Rockhampton North,
QLD 4702

No Asbestos Detected
