ASBESTOS CONTAINING MATERIALS SURVEY REPORT

Building 711 Demountable
Mackay Ooralea Campus

Report Number 622.10968.00000/0030-R01-ASR-BLD711

19 October 2017

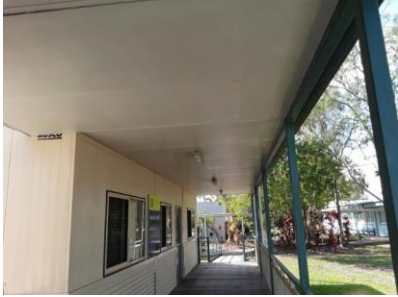
Ground Floor External	Porch Ceiling, Fibrous Cement	10m ²	NAD
Similar to 5-860

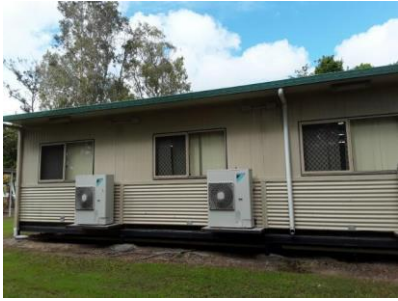
Ground Floor External	Eave, Fibrous Cement	8m ²	NAD

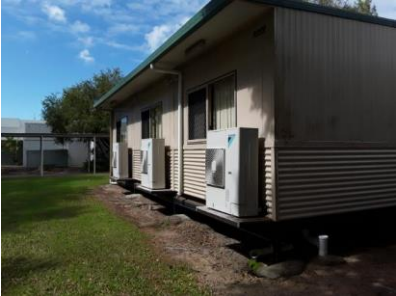
Ground Floor External	Base sheets for Air con units, Fibrous Cement	3m ²	NAD
