ASBESTOS CONTAINING MATERIALS SURVEY REPORT

Grounds Shed 3
Rockhampton City TAFE

Report Number 622.10968.00000/0090-R01-ASR-GroundsShed3

01 November 2017

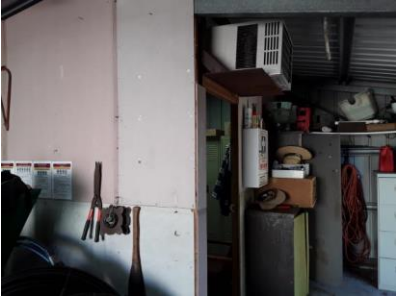
1st Floor INTERNAL WALL SHEETING	WALL SHEETING - NORTH AND EAST ELEVATIONS , Fibrous Cement	26m ²	NAD
