ASBESTOS CONTAINING MATERIALS SURVEY REPORT

Analysis and Planning
Building 067
Rockhampton North

Report Number 622.10968.00000/0040-R01-ASR-Bld067

27 December 2017

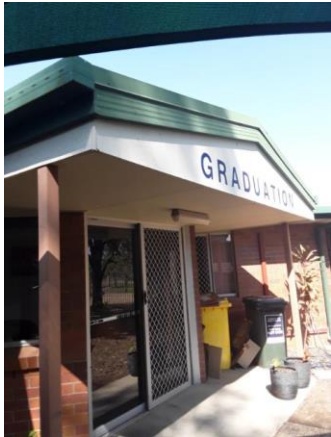
Sample No./ Visual Observation	Photo	Location			Analysis
		Int / Ext Floor Specific Location	Material Application	Extent	Result
1-299

External All eaves	Eave lining , Fibrous Cement	50m ²	NAD

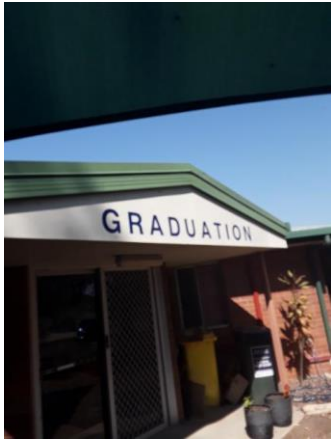
Sample No./ Visual Observation	Photo	Location			Analysis
		Int / Ext Floor Specific Location	Material Application	Extent	Result
1-300

External Gable facing main entrance	External cladding, Fibrous Cement	3m ²	NAD
Similar to 1-300

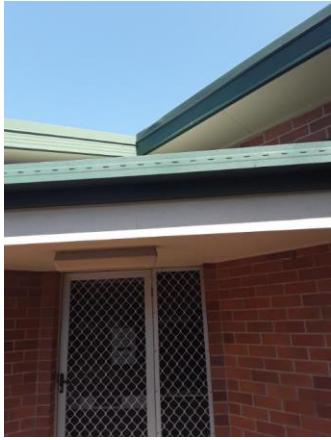
External Gable facing secondary entrance	External cladding, Fibrous Cement	2m ²	NAD

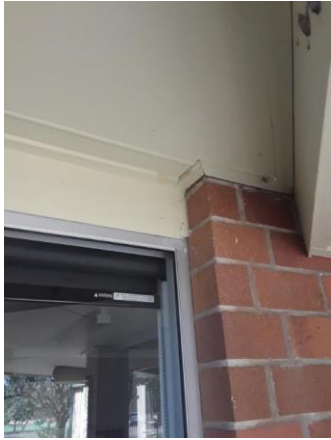
Sample No./ Visual Observation	Photo	Location			Analysis
		Int / Ext Floor Specific Location	Material Application	Extent	Result
1-301

External external windows	Infill panel above windows, Fibrous Cement	2m ²	NAD
1-302

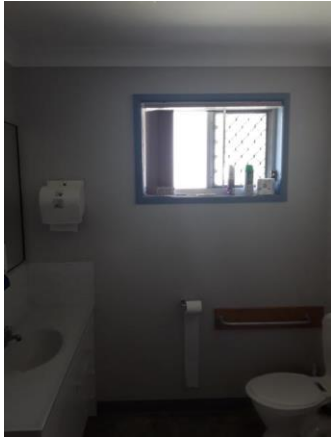
Ground Floor Bathroom	Internal wall, Fibrous Cement	12m ²	NAD

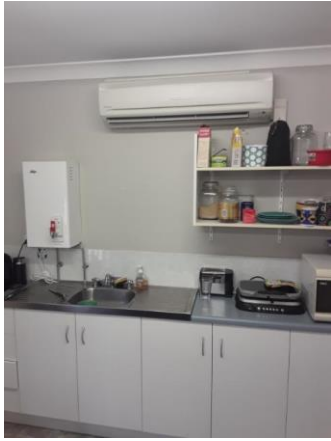
Ground Floor Kitchen	Internal wall, Fibrous Cement	12m ²	NAD
1-303

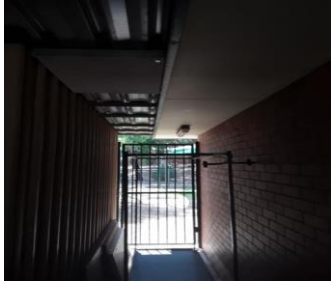
External Breezeway between shed and main building	Ceiling, Fibrous Cement	2m ²	NAD
