ASBESTOS CONTAINING MATERIALS SURVEY REPORT

Campus Security
Building 003
Rockhampton North

Report Number 622.10968.00000/0040-R01-ASR-Blg003

27 December 2017

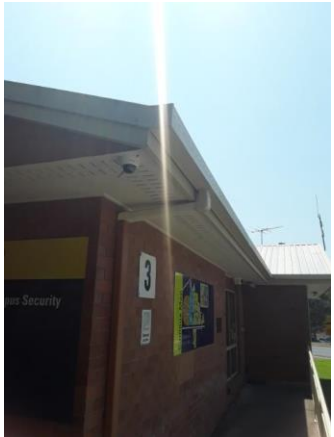
External All eaves	Eave lining , Fibrous Cement	45m ²	NAD

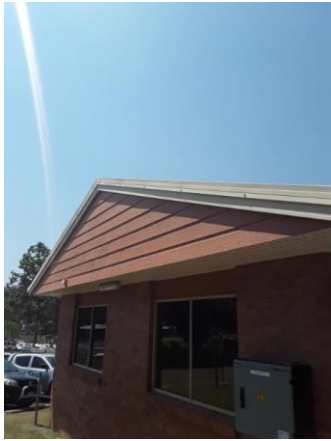
External Gable to rear of building	External cladding, Fibrous Cement	12m ²	NAD
Similar to 1-311

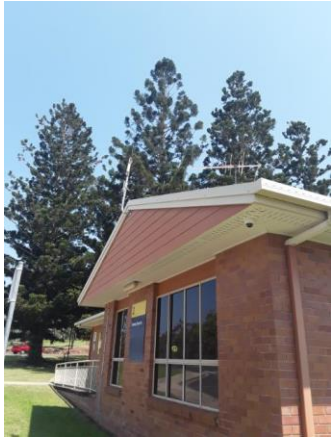
External Gable to front of building	External cladding, Fibrous Cement	12m ²	NAD

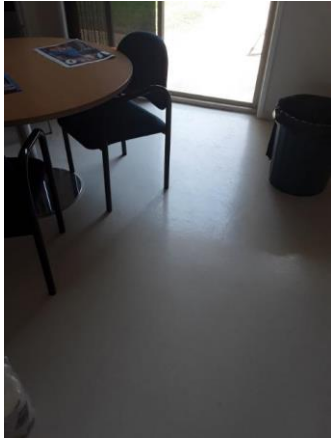
External Kitchen floor	Floor vinyl, Vinyl Products	20m ²	NAD
