## ASBESTOS CONTAINING MATERIALS SURVEY REPORT

Building 712 Demountable  
Mackay Ooralea Campus

Report Number 622.10968.00000/0030-R01-ASR-BLD712

19 October 2017

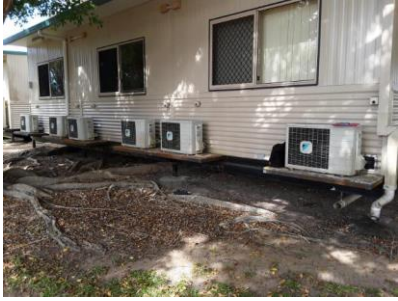
Sample No./ Visual Observation	Photo	Location			Analysis
		Int / Ext Floor Specific Location	Material Application	Extent	Result
5-865

Ground Floor External	Base sheets for Air con units, Fibrous Cement	6m <sup>2</sup>	NAD
