ASBESTOS CONTAINING MATERIALS SURVEY REPORT

Building 756 Accommodation Unit F
Mackay Ooralea Campus

Report Number 622.10968.00000/0030-R01-ASR-BLD756

19 October 2017

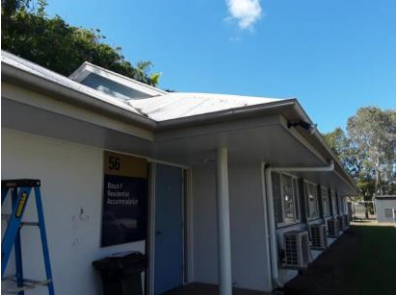
Sample No./ Visual Observation	Photo	Location			Analysis
		Int / Ext Floor Specific Location	Material Application	Extent	Result
5-848

Ground Floor External	Eave, Fibrous Cement	46m ²	NAD
