ASBESTOS CONTAINING MATERIALS SURVEY REPORT

Engineering High Lab
Building 084
Rockhampton North

Report Number 622.10968.00000/0040-R01-ASR-Bld84

19 January 2018

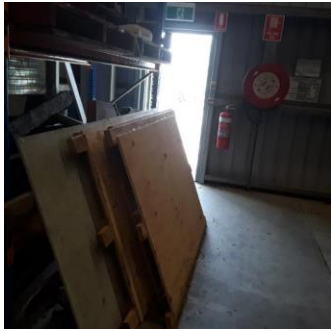
Sample No./ Visual Observation	Photo	Location			Analysis
		Int / Ext Floor Specific Location	Material Application	Extent	Result
1-794

Ground Floor Northwest elevation - stored compressed sheet	COMPRESSED SHEETING, Fibrous Cement	4m ²	NAD
