ASBESTOS CONTAINING MATERIALS SURVEY REPORT

Benke Studio/Drama Studio
Rockhampton North

Report Number 622.10968.00000/0040-R01-ASR-BLD 004

7 December 2017

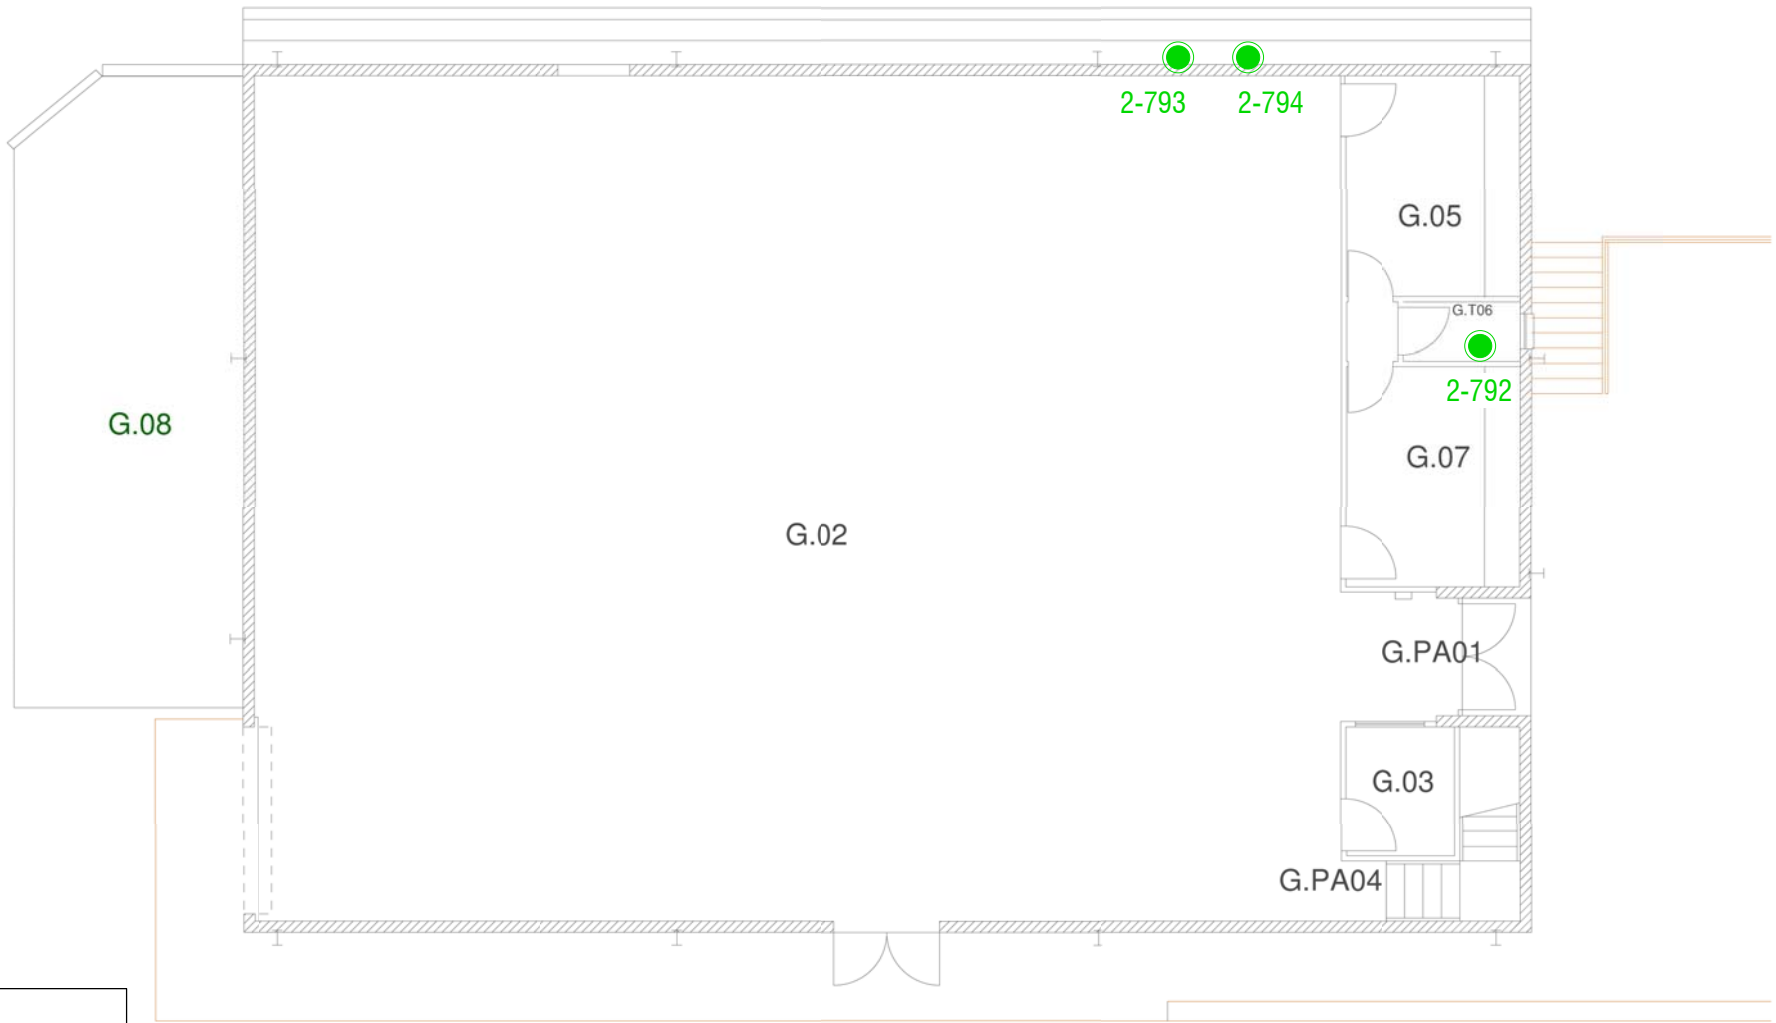
Building No:	004
Inspection Date:	Sept / Oct 2017
Inspected By:	NC
Figure No.:	SLR62210968-RN-004G-01
Drawn By:	LF
Drawn Date:	9/11/17

Sample location
No Asbestos Detected
