ASBESTOS CONTAINING MATERIALS SURVEY REPORT

Building 13 Language Centre
Rockhampton North

Report Number 622.10968.00000/0040-R01-ASR-BLD 13

7 December 2017

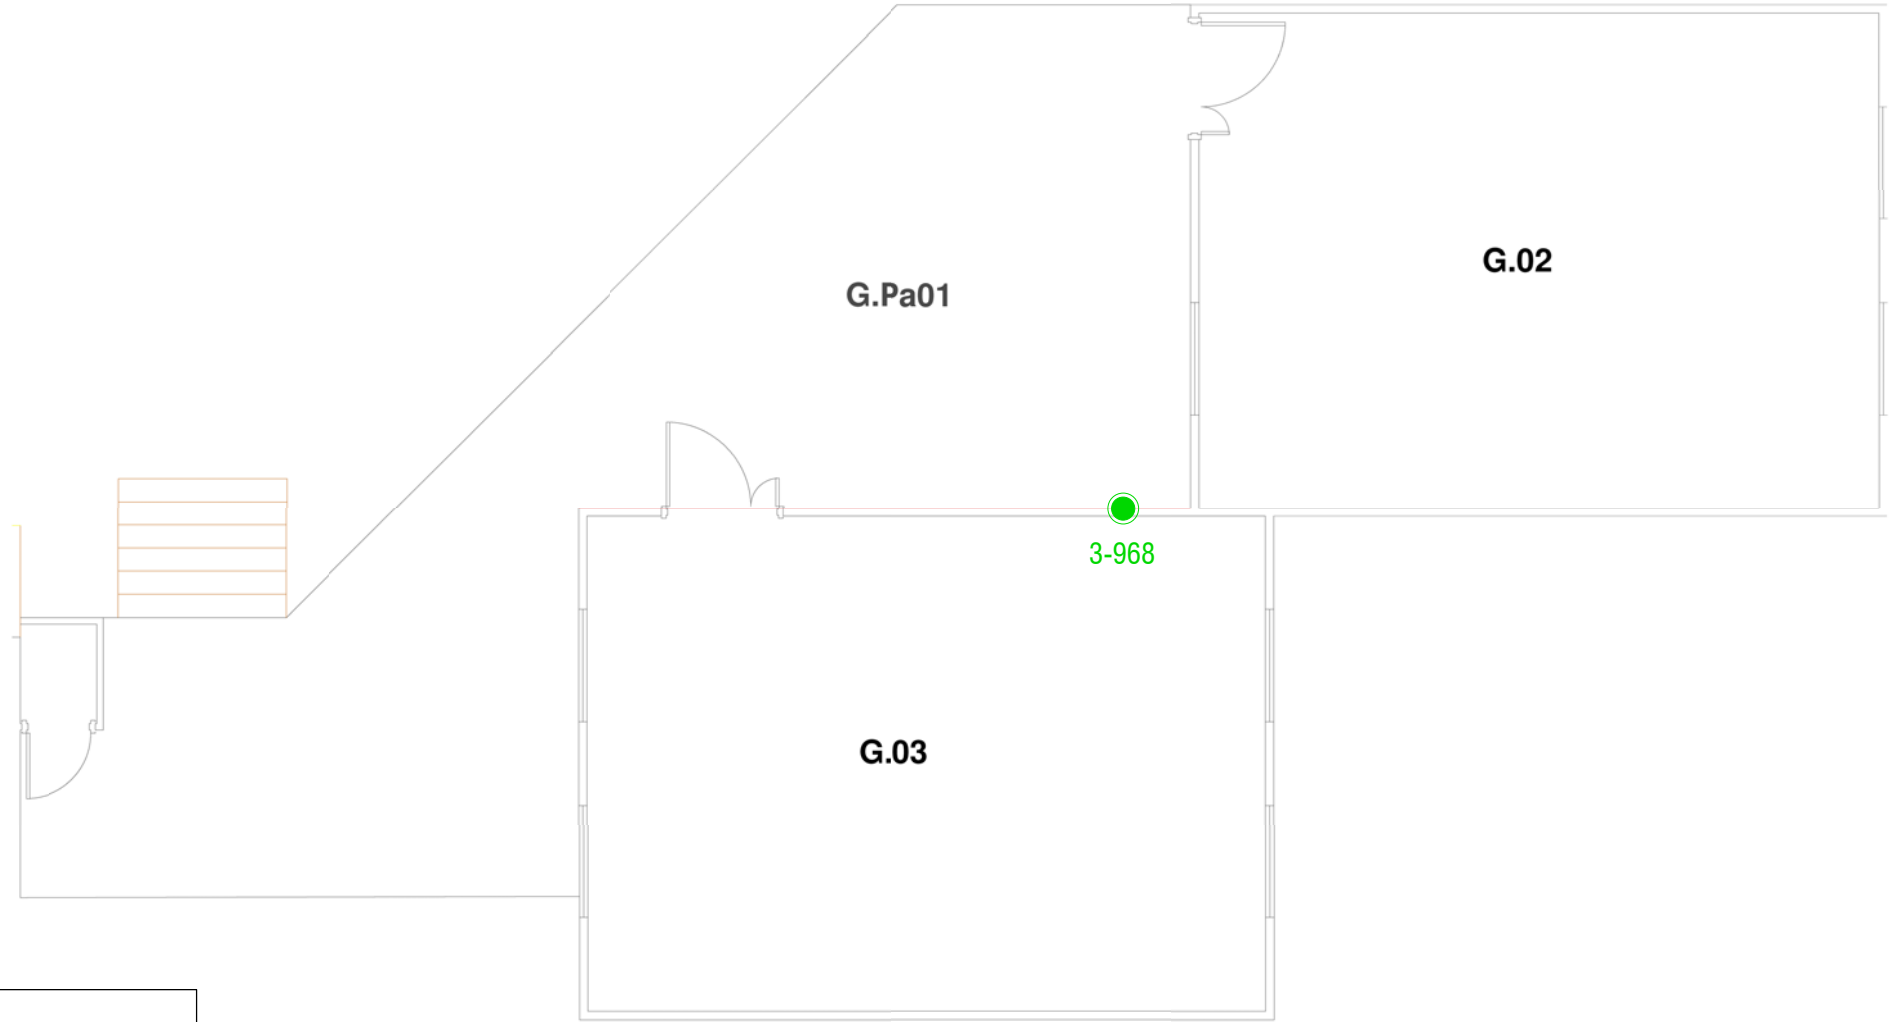
Site Plan

No Asbestos Detected
