ASBESTOS CONTAINING MATERIALS SURVEY REPORT

Fitness Centre
Building 025
Rockhampton North

Report Number 622.10968.00000/0040-R01-ASR-Bld25

27 December 2017

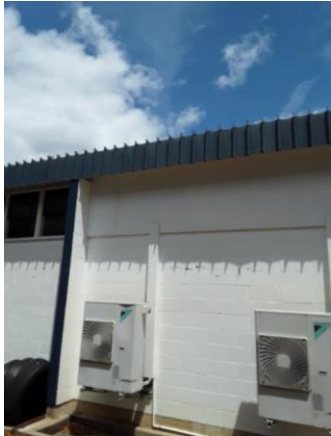
Sample No./ Visual Observation	Photo	Location			Analysis
		Int / Ext Floor Specific Location	Material Application	Extent	Result
1-340

External west wall	External cladding, Fibrous Cement	1m ²	NAD

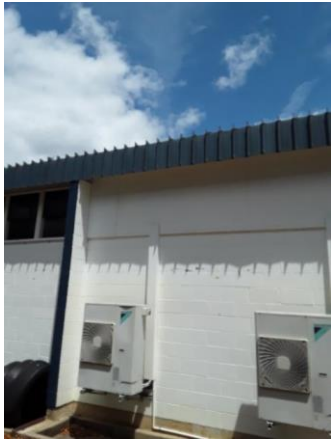
Sample No./ Visual Observation	Photo	Location			Analysis
		Int / Ext Floor Specific Location	Material Application	Extent	Result
1-341

External west wall	External cladding, Fibrous Cement	9m ²	NAD
1-342

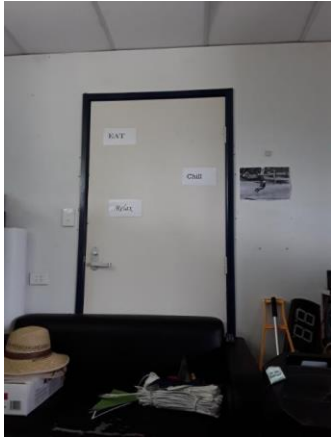
Ground Floor Storeroom behind reception	Internal walls, Fibrous Cement	12m ²	NAD

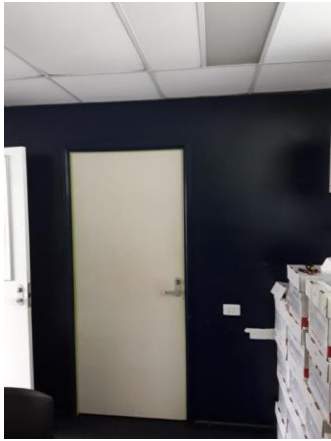
Sample No./ Visual Observation	Photo	Location			Analysis
		Int / Ext Floor Specific Location	Material Application	Extent	Result
1-343

Ground Floor Office adjacent reception	Internal walls, Fibrous Cement	26m ²	NAD
1-344

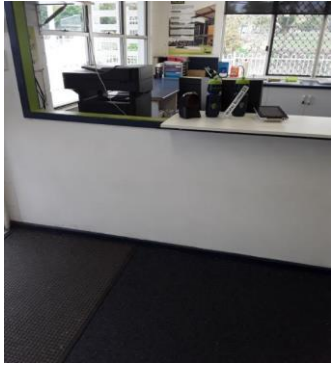
Ground Floor Reception counter	Internal walls, Fibrous Cement	10m ²	NAD
