ASBESTOS CONTAINING MATERIALS SURVEY REPORT

Building 702 DFM Workshop
Mackay Ooralea Campus

Report Number 622.10968.00000/0030-R01-ASR-BLD 702

19 October 2017

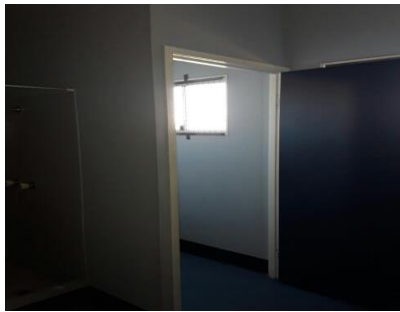
Ground Floor Unisex Toilet/shower	Wall, Fibrous Cement	36m ²	NAD
5-872

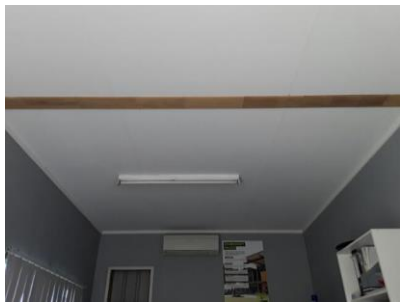
Ground Floor Kitchen	Ceiling, Fibrous Cement	21m ²	NAD

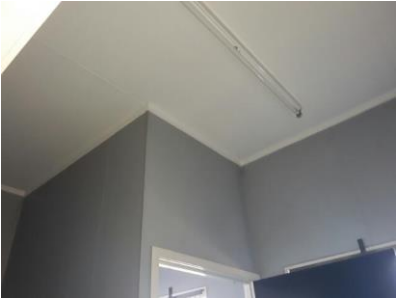
Ground Floor Unisex Toilet/shower	Ceiling, Fibrous Cement	8m ²	NAD
5-873

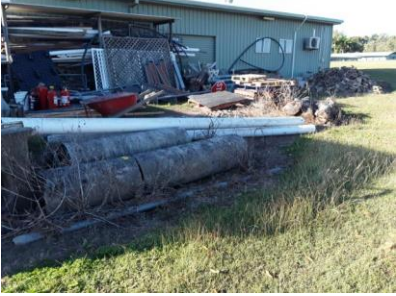
Ground Floor External	redundant pipes, Fibrous Cement	4lin m	NAD
