ASBESTOS CONTAINING MATERIALS SURVEY REPORT

Building 720 Bookshop & Chiropractic
Mackay Ooralea Campus

Report Number 622.10968.00000/0030-R01-ASR-BLD720

19 October 2017

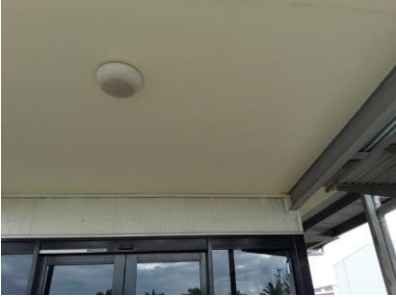
Ground Floor External	Soffit, Fibrous Cement	15	NAD
Similar to 5-857 Sampled in Building 721

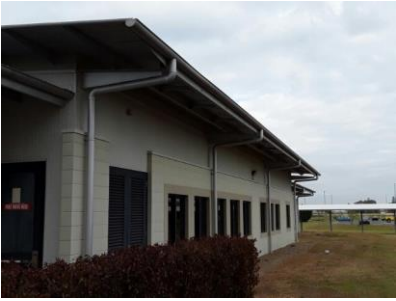
Ground Floor External	Fascia , Fibrous Cement	45m ²	NAD
