## ASBESTOS CONTAINING MATERIALS SURVEY REPORT

Building 757 Accommodation Unit G  
Mackay Ooralea Campus

Report Number 622.10968.00000/0030-R01-ASR-BLD757

19 October 2017

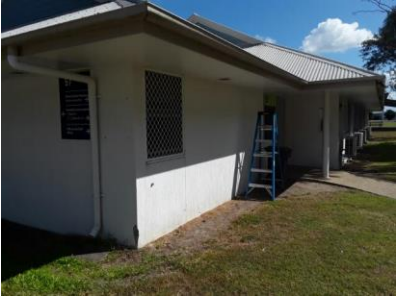
Sample No./ Visual Observation	Photo	Location			Analysis
		Int / Ext Floor Specific Location	Material Application	Extent	Result
5-849

Ground Floor External	Eave, Fibrous Cement	46m <sup>2</sup>	NAD
