ASBESTOS CONTAINING MATERIALS SURVEY REPORT

Vacant
Rockhampton North

Report Number 622.10968.00000/0040-R01-ASR-BLD200

BLD 200 - Vacant
Rockhampton North

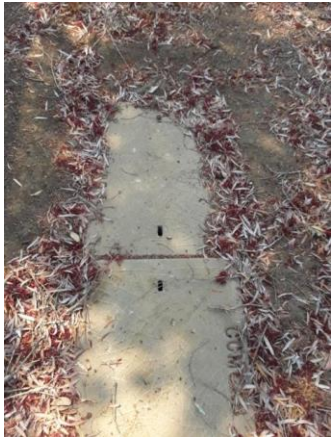
External rear of building	Service pit cap, Fibrous Cement	1m ²	NAD

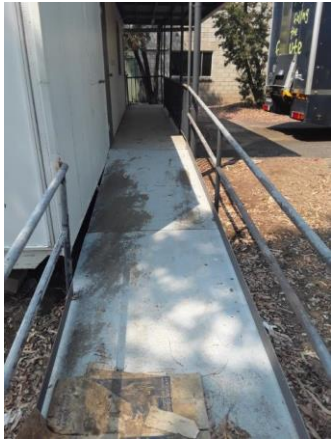
External Ramp to building	Floor, Fibrous Cement	13m ²	NAD
1-281

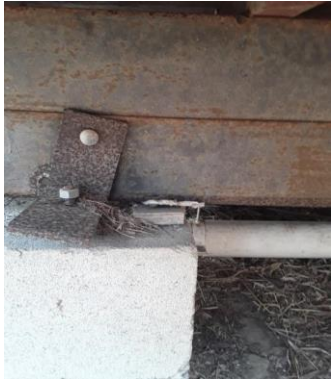
External Beneath building	Packers to bearers, Fibrous Cement	1m ²	NAD
