ASBESTOS CONTAINING MATERIALS SURVEY REPORT

Building 721 Conservatorium
Mackay Ooralea Campus

Report Number 622.10968.00000/0030-R01-ASR-BLD721

19 October 2017

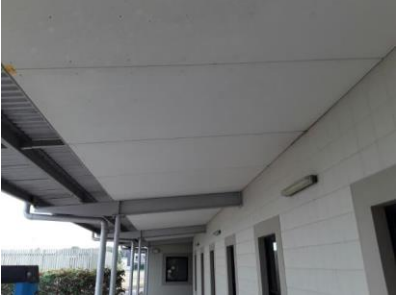
Ground Floor External	Soffit, Fibrous Cement	60m ²	NAD
5-857

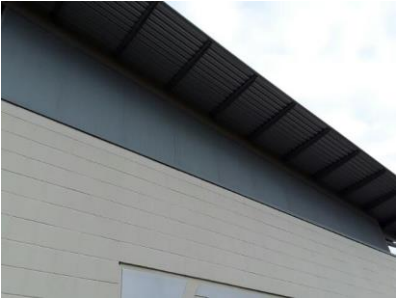
Ground Floor External	Fascia , Fibrous Cement	60m ²	NAD
