ASBESTOS CONTAINING MATERIALS SURVEY REPORT

Building 758 Private Use Building
Mackay Ooralea Campus

Report Number 622.10968.00000/0030-R01-ASR-BLD758

19 October 2017

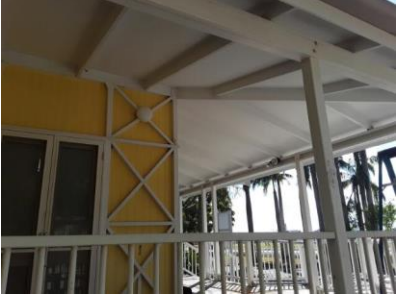
Sample No./ Visual Observation	Photo	Location			Analysis
		Int / Ext Floor Specific Location	Material Application	Extent	Result
5-851

Ground Floor External	Porch Eave, Fibrous Cement	55m ²	NAD
5-850

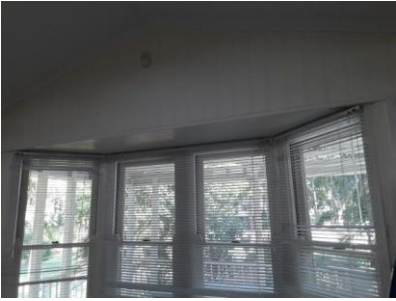
Ground Floor Open area south side of kitchen	Ssmall section ceiling , Fibrous Cement	2m ²	NAD

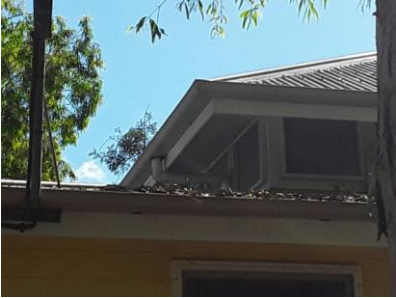
Sample No./ Visual Observation	Photo	Location			Analysis
		Int / Ext Floor Specific Location	Material Application	Extent	Result
Similar to 5-851

Ground Floor External	upper eave, Fibrous Cement	20m ²	NAD
