ASBESTOS CONTAINING MATERIALS SURVEY REPORT

Building 704 DFM Building
Mackay Ooralea Campus

Report Number 622.10968.00000/0030-R01-ASR-BLD704

19 October 2017

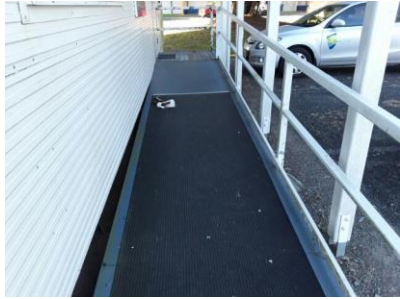
Ground Floor External	Entrance ramp, Fibrous Cement	10m ²	NAD
5-875

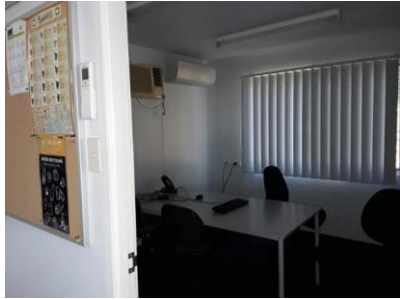
Ground Floor Office	Wall, Fibrous Cement	104m ²	NAD

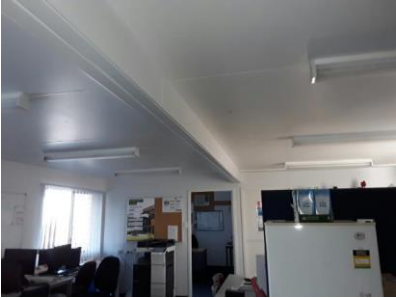
Ground Floor Entire building	Ceiling, Fibrous Cement	80m ²	NAD
