ASBESTOS CONTAINING MATERIALS SURVEY REPORT

Facilities Management Space Storage
Building 209
Rockhampton North

Report Number 622.10968.00000/0040-R01-ASR-Bld209

27 December 2017

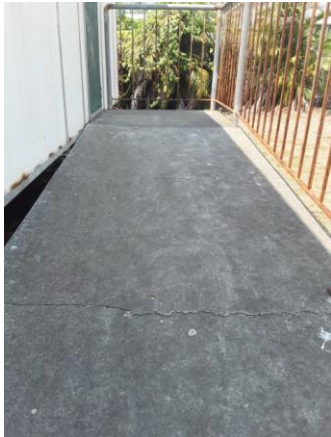
External ramp	Concrete , Fibrous Cement		NAD
