ASBESTOS CONTAINING MATERIALS SURVEY REPORT

Biology Laboratories
Building 017
Rockhampton North

Report Number 622.10968.00000/0040-R01-ASR-Bld017

27 December 2017

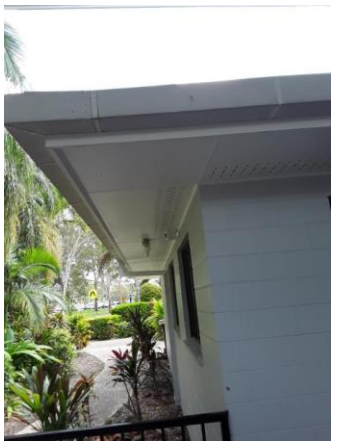
Eaves - all sides	Eave lining , Fibrous Cement	110m ²	NAD
