ASBESTOS CONTAINING MATERIALS SURVEY REPORT

Building 705 Student Refectory
Mackay Ooralea Campus

Report Number 622.10968.00000/0030-R01-ASR-BLD705

19 October 2017

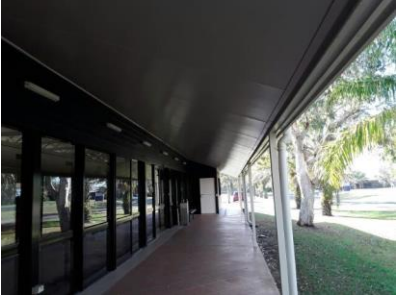
| Sample No./ Visual Observation | Photo | Location | | | Analysis |
|---|--|---|---|---|---|
| 5-876 | | Ground Floor External | Soffit, Fibrous Cement | 60m ² | NAD |

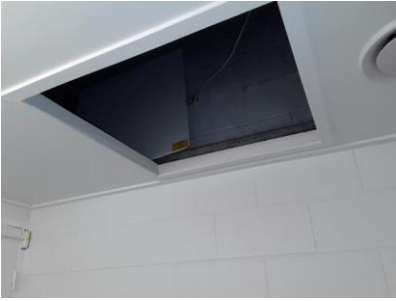
| Sample No./ Visual Observation | Photo | Location | | | Analysis |
|---|--|---|---|---|---|
| 5-877 | | Ground Floor G-08 Disable Toilet | Ceiling access panel, Fibrous Cement | <1m ² | NAD |

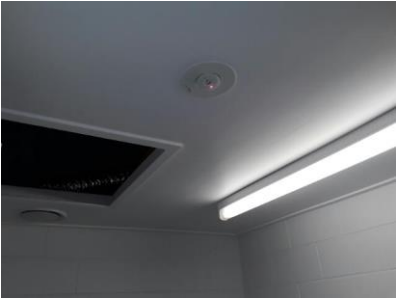
| Sample No./ Visual Observation | Photo | Location | | | Analysis |
|---|---|---|---|---|---|
| Similar to 5-877 | | Ground Floor G-08 Disable Toilet | Ceiling, Fibrous Cement | 4m ² | NAD |

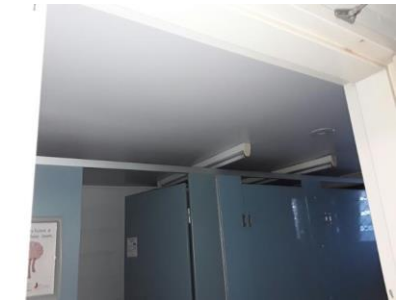
| Sample No./ Visual Observation | Photo | Location | | | Analysis |
|---|---|---|---|---|---|
| Similar to 5-877 | | Ground Floor G-09 Female Toilets | Ceiling, Fibrous Cement | 8m ² | NAD |

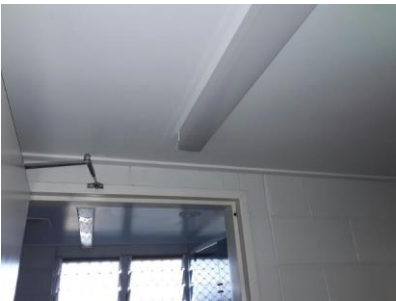
| Sample No./ Visual Observation | Photo | Location | | | Analysis |
|---|---|---|---|---|---|
| Similar to 5-877 | | Ground Floor G-10 Male Toilets | Ceiling, Fibrous Cement | 8m ² | NAD |

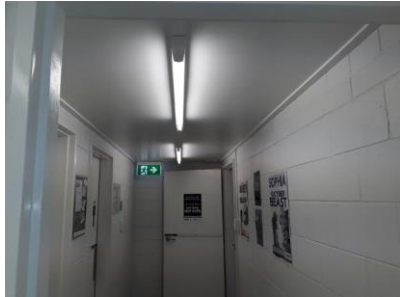
| Sample No./ Visual Observation | Photo | Location | | | Analysis |
|---|---|---|---|---|---|
| Similar to 5-877 | | Ground Floor G-07 Corridor to Toilets | Ceiling, Fibrous Cement | 8m ² | NAD |
