## ASBESTOS CONTAINING MATERIALS SURVEY REPORT

Building 750 Campus Reception /Security  
Mackay Ooralea Campus

Report Number 622.10968.00000/0030-R01-ASR-BLD750

19 October 2017

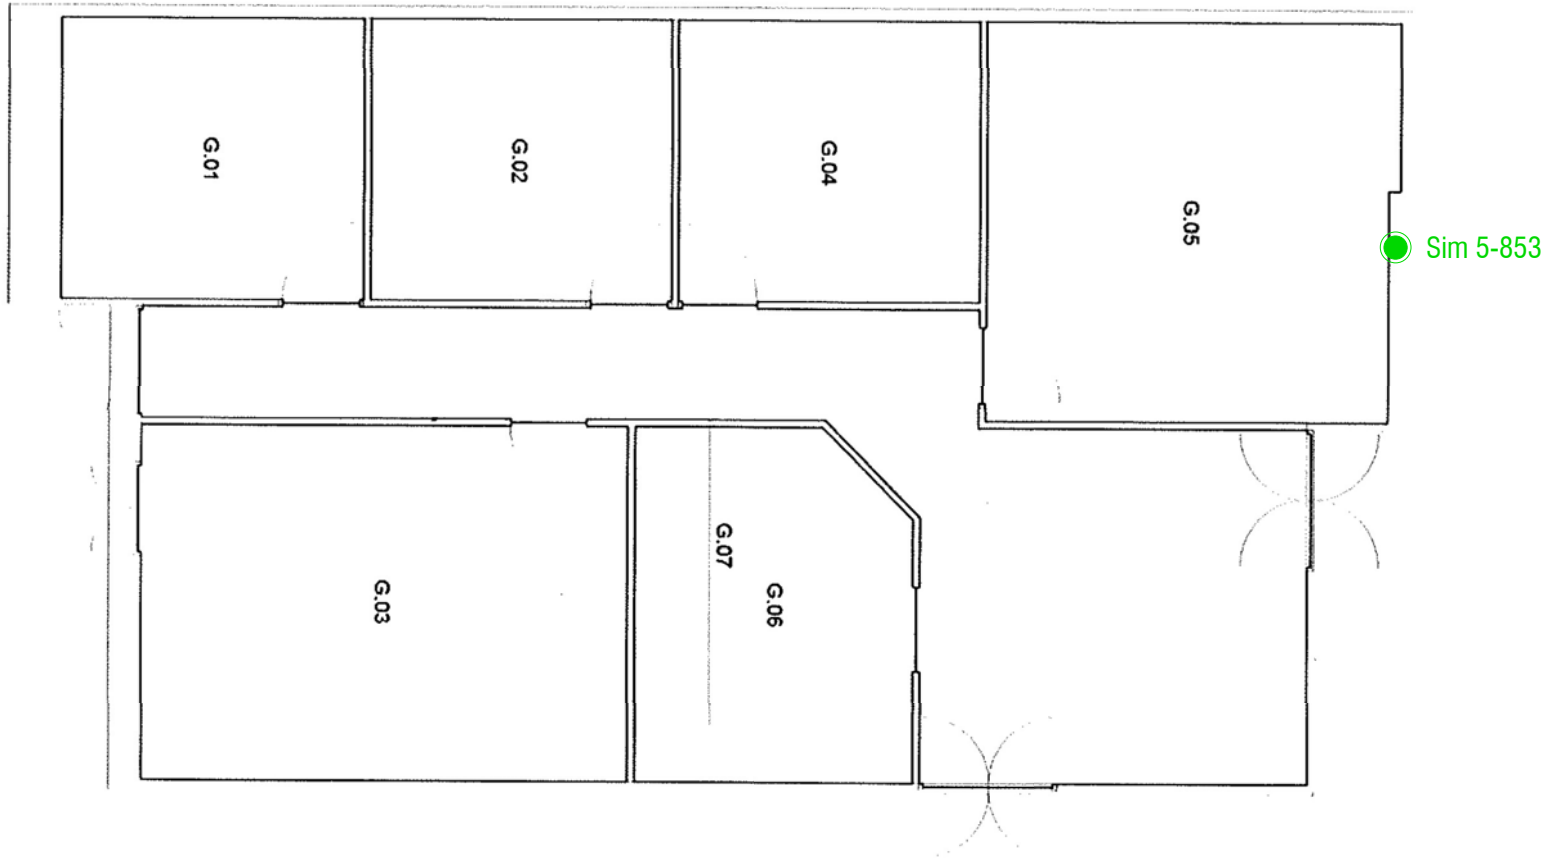
Building No:	750
Inspection Date:	2/08/17 - 4/08/17
Inspected By:	NC
Figure No.:	SLR62210968-750-01
Drawn By:	LF
Drawn Date:	24/10/17

Sample location  
No Asbestos Detected
