ASBESTOS CONTAINING MATERIALS SURVEY REPORT

Building 761 Fire Pump shed
Mackay Ooralea Campus

Report Number 622.10968.00000/0030-R01-ASR-BLD761

19 October 2017

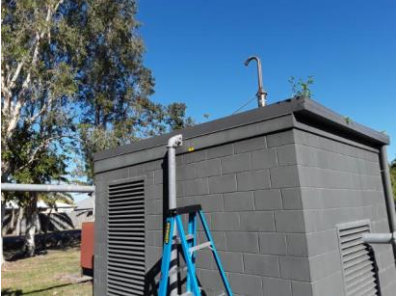
Sample No./ Visual Observation	Photo	Location			Analysis
		Int / Ext Floor Specific Location	Material Application	Extent	Result
5-854		Ground Floor internal	pipe lining, Woven Product	5lin m	NAD
5-855

Ground Floor External	upper infill, Fibrous Cement	2m ²	NAD

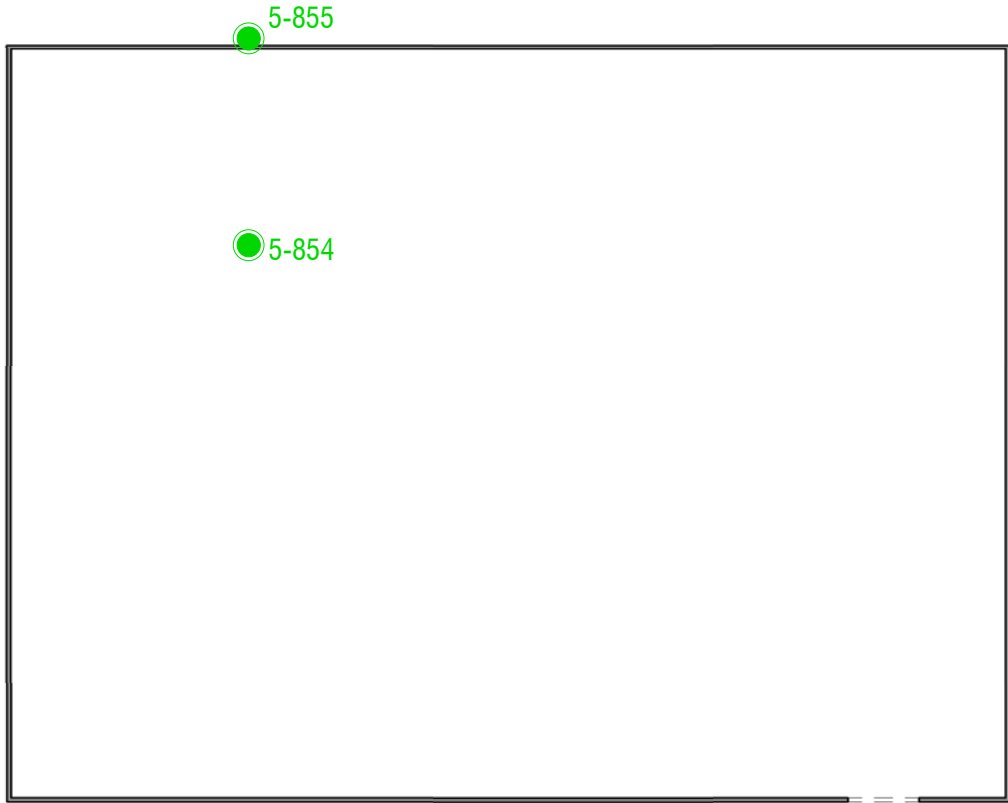
Building No:	761
Inspection Date:	2/08/17 - 4/08/17
Inspected By:	NC
Figure No.:	SLR62210968-761-01
Drawn By:	LF
Drawn Date:	24/10/17

Samples location
- No asbestos detected
