## ASBESTOS CONTAINING MATERIALS SURVEY REPORT

Block C  
Rockhampton City TAFE

Report Number 622.10968.00000/0090-R01-ASR-Block C

01 November 2017

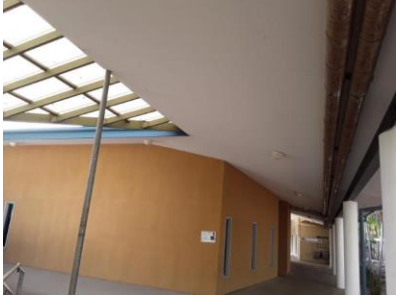
1st Floor EXTERNAL WALKWAY CEILING SHEETING - ALL ELEVATIONS	CEILING SHEETING, Fibrous Cement	220m <sup>2</sup>	NAD
3-919

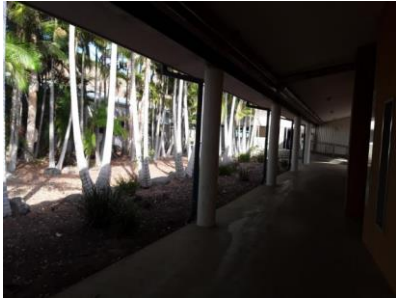
1st Floor EXTERNAL COLOUMS	EXTERNAL COLOUMS - WEST ELEVATION, Fibrous Cement	5no	NAD
