ASBESTOS CONTAINING MATERIALS SURVEY REPORT

Building 706 Academic Building B
Mackay Ooralea Campus

Report Number 622.10968.00000/0030-R01-ASR-BLD706

19 October 2017

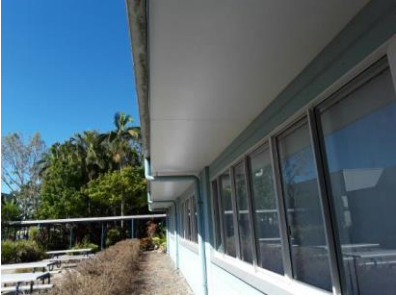
Ground Floor External	Soffit, Fibrous Cement	90m ²	NAD
5-867

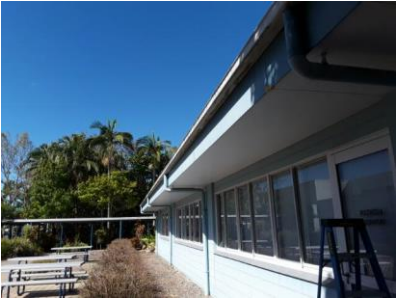
Ground Floor External	Fascia , Fibrous Cement	70m ²	NAD
