ASBESTOS CONTAINING MATERIALS SURVEY REPORT

Building 751 Dining and Conference Room A
Mackay Ooralea Campus

Report Number 622.10968.00000/0030-R01-ASR-BLD751

19 October 2017

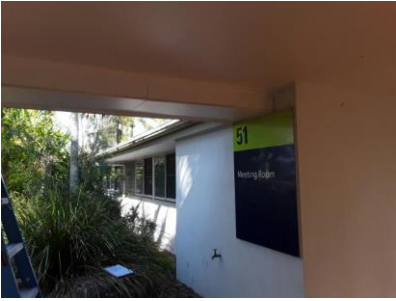
Ground Floor External	Eave, Fibrous Cement	60m ²	NAD

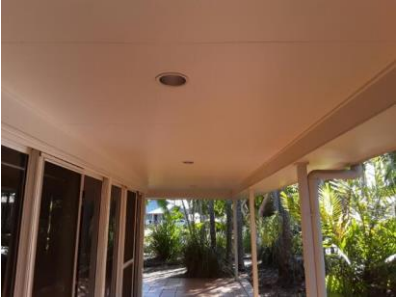
Ground Floor External	Walk way ceiling, Fibrous Cement	25m ²	NAD
