## ASBESTOS CONTAINING MATERIALS SURVEY REPORT

Building 752 Accommodation Unit B  
Mackay Ooralea Campus

Report Number 622.10968.00000/0030-R01-ASR-Building 752

19 October 2017

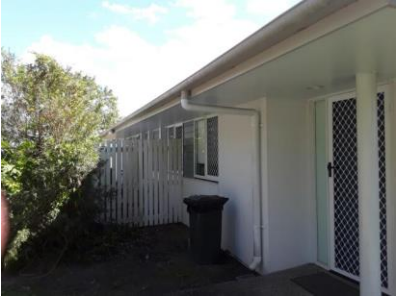
Sample No./ Visual Observation	Photo	Location			Analysis
		Int / Ext Floor Specific Location	Material Application	Extent	Result
5-844

Ground Floor External	Eave, Fibrous Cement	46m <sup>2</sup>	NAD

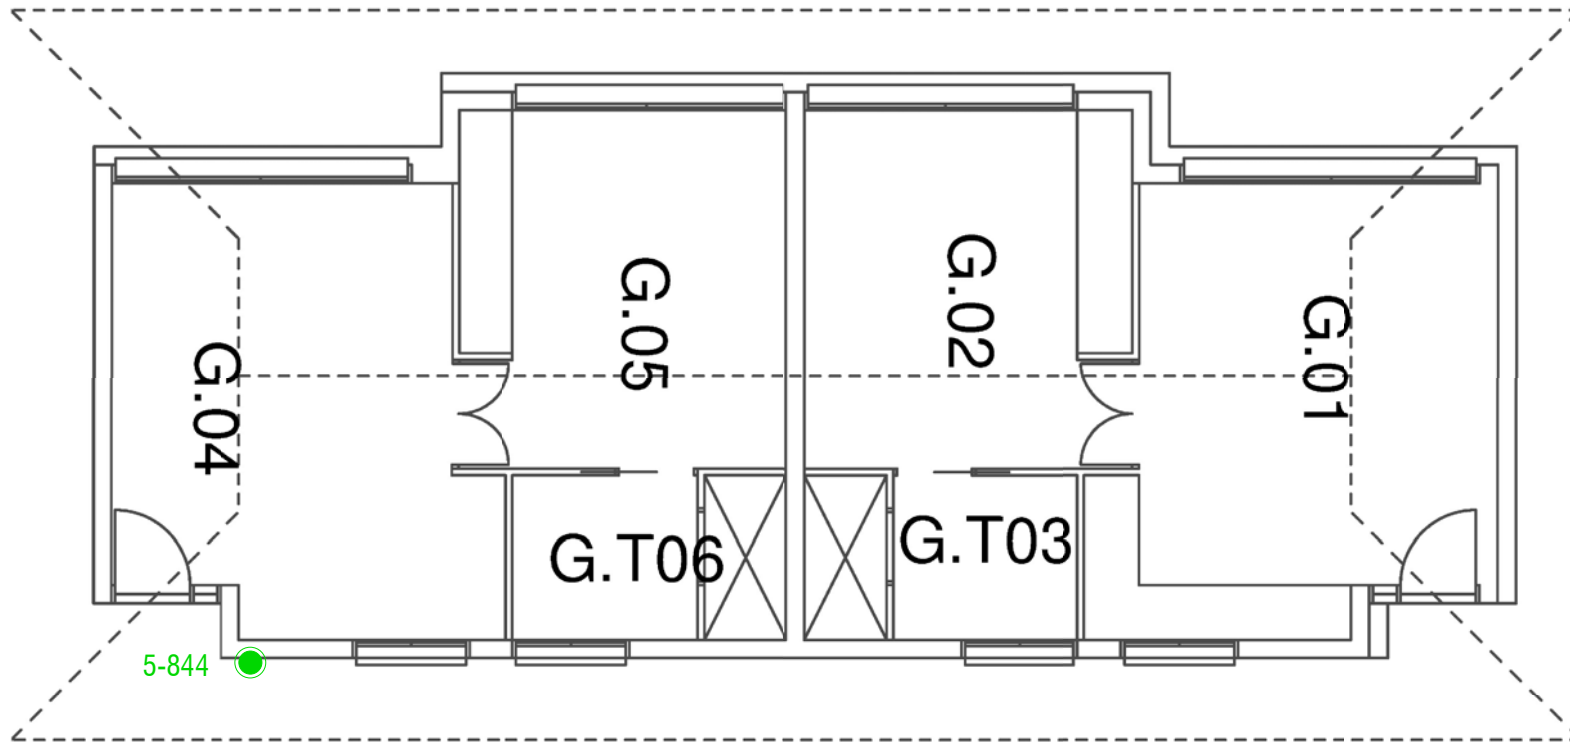
Building No:	752
Inspection Date:	2/08/17 - 4/08/17
Inspected By:	NC
Figure No.:	SLR62210968-752-01
Drawn By:	LF
Drawn Date:	14/9/17

Sample location  
No Asbestos Detected
