ASBESTOS CONTAINING MATERIALS SURVEY REPORT

Gymnasium (Residential Precinct)
Building 057
Rockhampton North

Report Number 622.10968.00000/0040-R01-ASR-Bld 57

19 January 2018

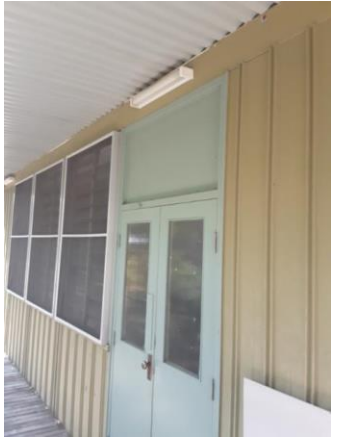
External Office	External wall - infill above doors,	2m ²	NAD

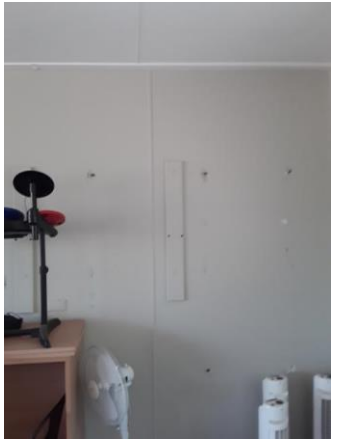
Ground Floor internal wall	Internal wall,	60m ²	NAD
