ASBESTOS CONTAINING MATERIALS SURVEY REPORT

Building 753 Accommodation Unit C
Mackay Ooralea Campus

Report Number 622.10968.00000/0030-R01-ASR-BLD753

19 October 2017

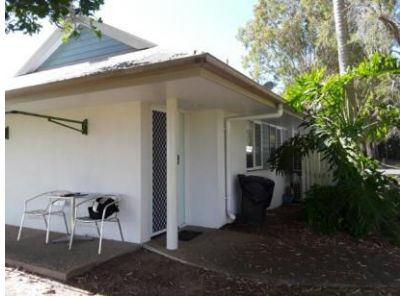
| Sample No./ Visual Observation | Photo | Location | | | Analysis |
|---|---|---|---|---|---|
| 5-843 | | Ground Floor External | Eave, Fibrous Cement | 46m ² | NAD |
