ASBESTOS CONTAINING MATERIALS SURVEY REPORT

Nulloo Yumba
Building 031
Rockhampton North

Report Number 622.10968.00000/0040-R01-ASR-Bld031

28 November 2017

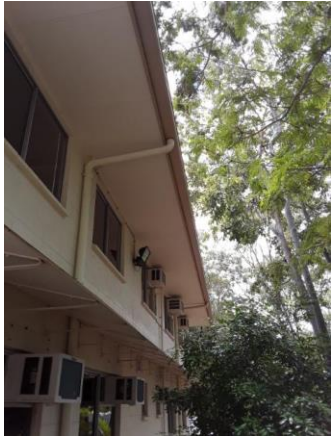
| Sample No./ Visual Observation | Photo | Location | | | Analysis |
|---|--|---|---|---|---|
| 1-428 | | External All External eaves | Eave lining , Fibrous Cement | 80m ² | NAD |

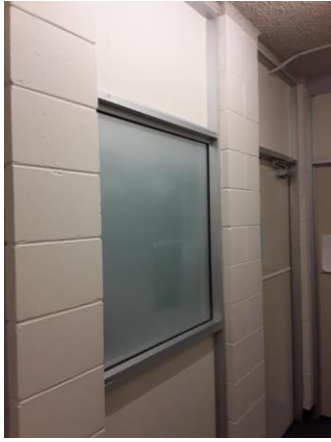
| Sample No./ Visual Observation | Photo | Location | | | Analysis |
|---|---|---|---|---|---|
| 1-429 | | External Doors and windows throughout | Infill panels, Fibrous Cement | | NAD |
